Chaldon Herring Conservation Area

Appraisal document

Adopted Document

December 2014

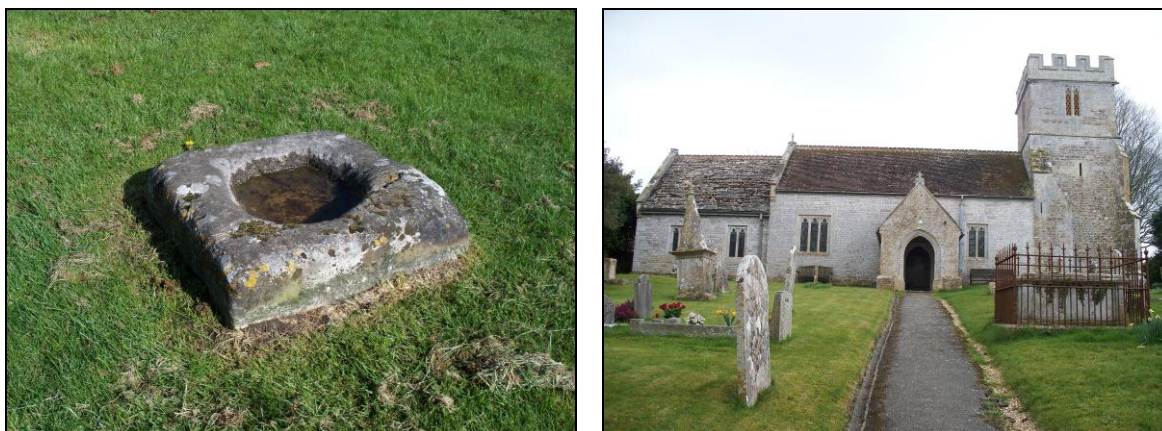
FIG. 2: *Medieval relics. Left: Cross base on the green. Right: St. Nicholas's Church.*

17. St Nicholas's Church stands on the highest ground within the village, giving emphasis to its historic importance. The building here dates at least to the fourteenth century, with the tower and porch added during the fifteenth century, and the chancel and south aisle rebuilt during the nineteenth. The twelfth century font may provide evidence for an earlier building on the site, however its exact provenance is open to question given that it spent time as a garden ornament.

century. Shrinkage of villages during the medieval period was often associated with loss of population arising from plague, though the exact cause of shrinkage in Chaldon Herring is unknown. The stone base of a village cross survives on the village green.

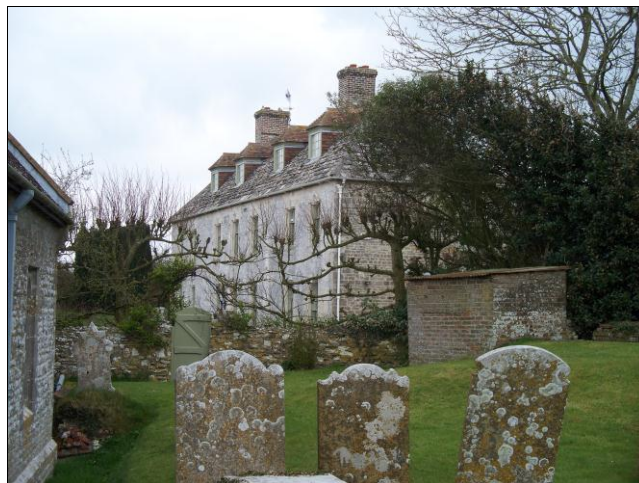
FIG. 3: *The Manor (formerly The Grange). As viewed from the churchyard.*

20. The Manor is of sixteenth century origin, and though the house, and particularly the facade, was remodelled during the eighteenth century, it retains substantial fabric dating to the period (see FIG. 3 below). Following dissolution of the Abbey in 1541, its lands passed to Sir Thomas Poynings, who established his seat at Burngate. By 1582 the Poynings estate was largely united with that of the Howards who had succeeded in ownership of the adjoining de Newburgh estate. The Howards built Lulworth Castle in the 1600s. When the Welds purchased the Lulworth estate in 1641 Chaldon Herring was excluded, sold instead to the powerful Seymour family (later Dukes of Beaufort).

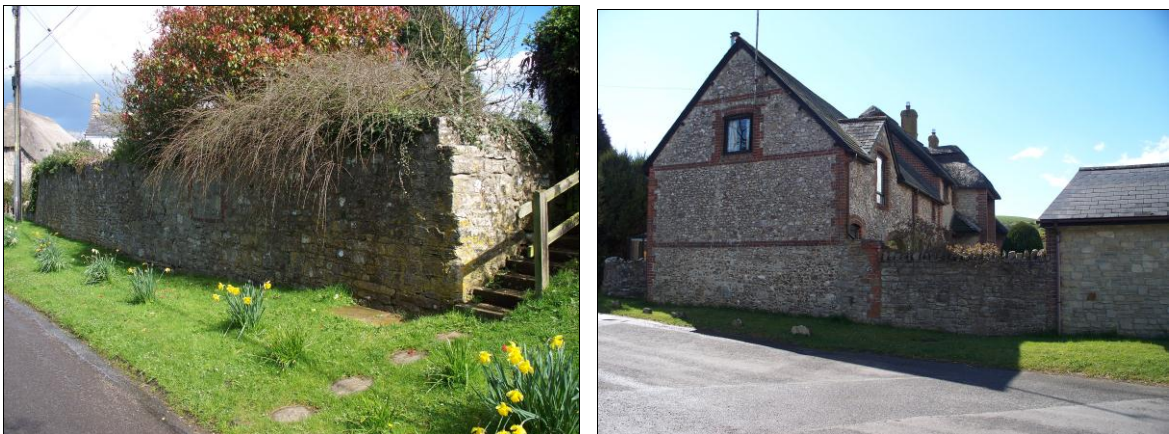
FIG. 4: Evidence of historic agricultural activity. Left: the outer walls of a former barn at Vicarage Farm. Right: 'Ford's Barn'. The 'Granary' is a remnant of the historic group of buildings which formed a courtyard here, the blocked entrance to which sits between it and 'Granary Lodge'. Both the latter and the remaining building here have either been substantially or completely rebuilt as part of the conversion.

demolished. Part of the external wall of a barn which belonged to Vicarage Farm now provides the roadside boundary, complete with blocked window opening (see FIG. 4 below). Ford's Barn opposite (see FIG. 4) was partially demolished, with much of the remainder reconstructed as part of its conversion during the 1980s. Of what remains, the Granary and part of Granary Lodge retain historic fabric, and stand either side of the now blocked entrance to the original yard. Remnants and ruins of the complex of buildings associated with Beaufort Farm and Vicarage Dairy survive at the eastern entry to the village.

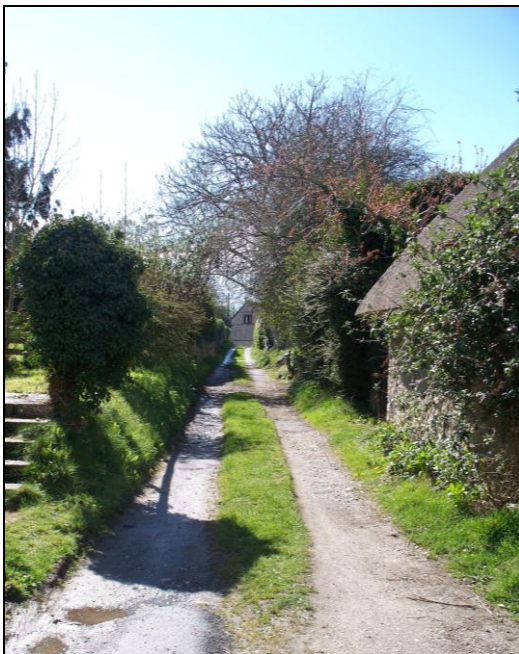
FIG. 5: Track linking Chydock Road to the West Chaldon road (apparently known locally as Bloater Lane). The gable end of the 'Granary' closes the view. The lane lends an informal rural character.

29. A triangular green stands at the centre of the village, approached by through roads which branch south, east and north-west. A looping route which encloses a large chunk of land south of the green, is created by a framework of secondary lanes (see FIG. 5). This relatively simple structure provides an interesting layered townscape within which the spaces enclosed by roads and accesses are important.

38. Consistent with the historic character of the village, the conservation area has remained free from introduction of pavements. Road surfaces are tarmacked with the exception of the lane linking Chydock Road with the West Chaldon road (see FIG. 5).

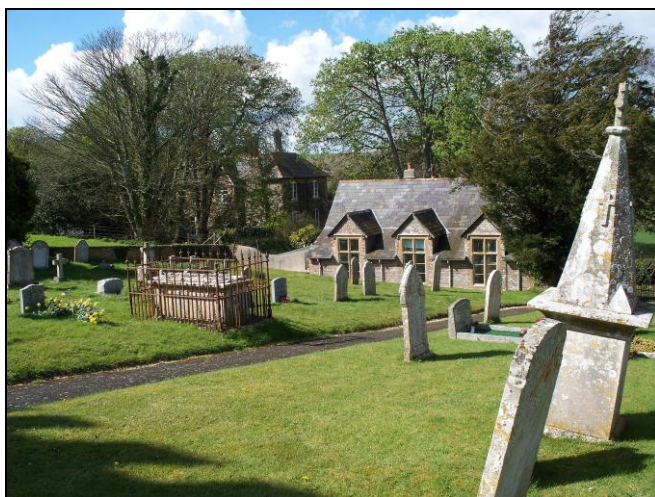
FIG. 7: *View across the churchyard. The former school and Old Vicarage are visible together with a collection of interesting monuments. Note the elevated position and contribution made by trees.*

36. The combination of layout, topography and the often informal arrangement of development gives rise to many attractive views moving around the conservation area. Views across the green and around the churchyard are of particular quality (see FIGs. 7 and 8). Also notable is the view west along the lane linking Chydock Road to the West Chaldon road, to which the gable end of The Granary provides a visual terminus (see FIG. 5). The broader landscape setting of the village (see FIG. 1) is appreciable from rising ground to the south, and this provides views into the village, whilst also providing a focus for views out.

- *The Old Vicarage*: whilst the use of brick is not typical of the locality, the building is architecturally attractive. It makes a positive contribution to views from the churchyard (see FIG. 7), and its appearance is mellowed by lichen.

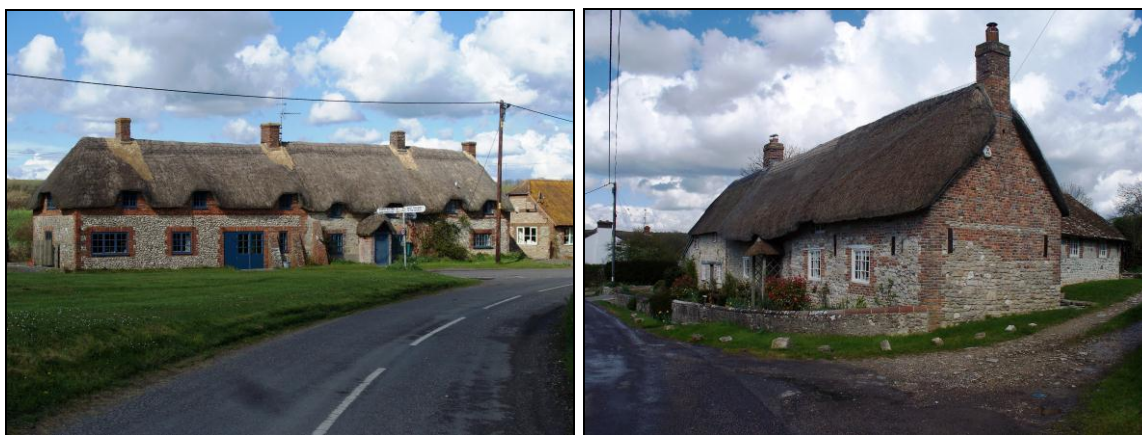
FIG. 9: Vernacular development. Left: No. 7, historically Damer's Farmhouse. The core of the building is one of the oldest houses in the village.. Right: St. Nicholas Cottage. Note also apparent patching with brick.

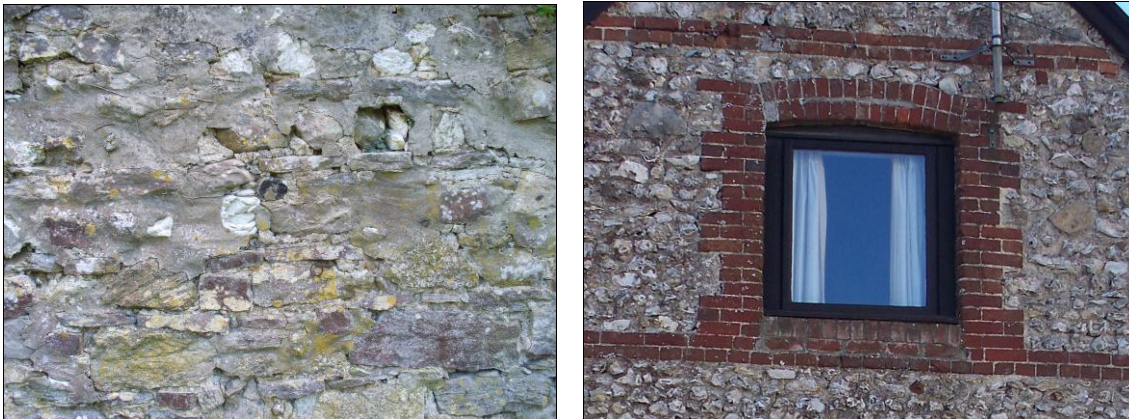
FIG. 10: Stone and brick. Left: Mixed rubble containing limestone, flint and chalk at Vicarage Farm. Right: Flint wall with brick dressings seen at the Granary.

rubble is more common. The latter may be found mixed with flint and chalk in the most roughly built walls (see FIG. 10 below).

46. Brick is used to form openings, corners and string courses in buildings constructed from flint, and often those constructed using mixed or limestone rubble (see FIG. 10 above). Brick is also generally used for construction of chimney stacks, and appears to have been used to patch up or reface a number of historic buildings (see for example St.Nicholas Cottage in FIG. 9).
47. Whilst brick represents a principal building material at a couple of nineteenth century properties, it does not otherwise play a significant role in characterising historic development within the conservation area. Brick has however been favoured for modern bungalow developments around the village, and this tends to appear visually obtrusive.

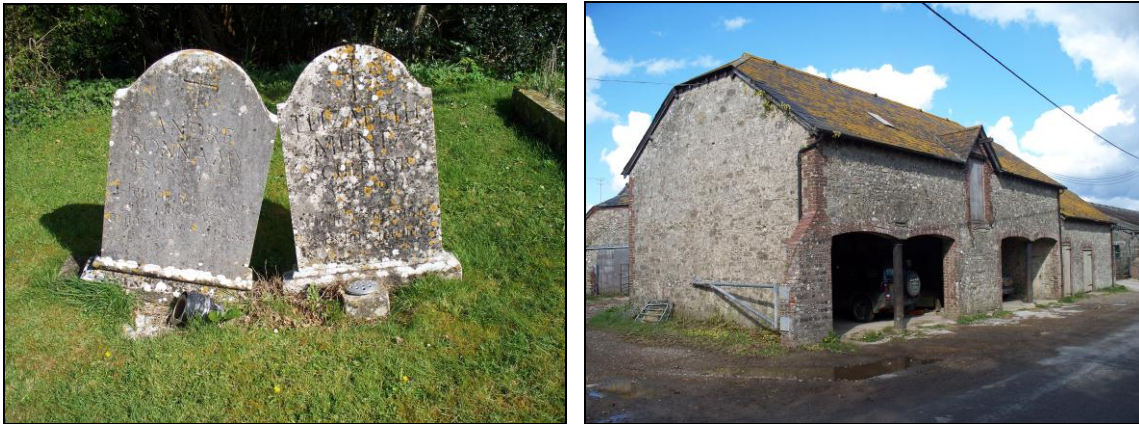
FIG. 11: *Features of interest. Left: tombstones of Andre Bonnamy and Elizabeth Muntz. Right: nineteenth century cart shed with first floor granary and attached stable.*

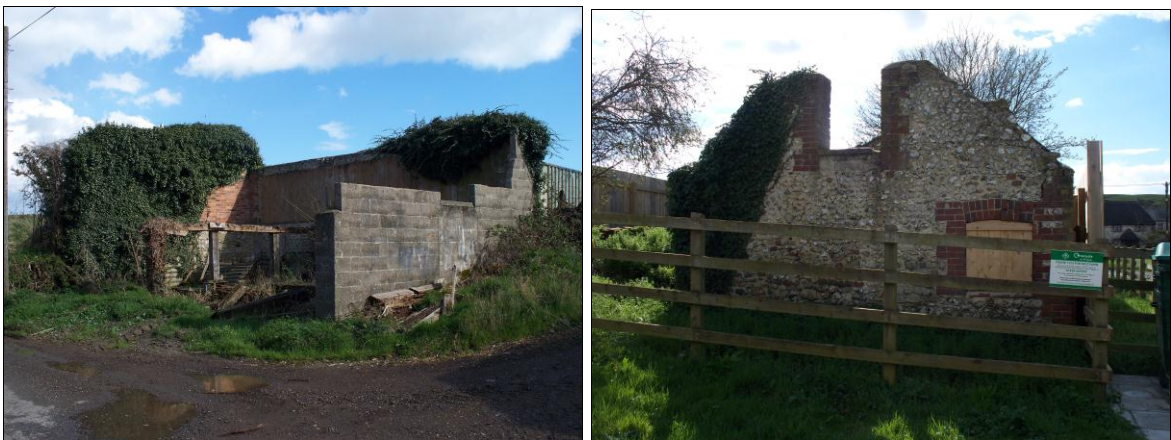
58. Following its inaugural survey of conservation areas in 2009, Chaldon Herring was declared as 'at risk' by English Heritage, and was featured in its magazine *Heritage Today*. Whilst this status has now been removed following progress shown in tackling dereliction, the condition of other buildings had deteriorated further. These include the ruins of a former farm building visible upon entering the village from the east, and the Old Forge discussed further below (see FIG. 13). Within the churchyard the tombstones of Elizabeth Muntz and Andre Bonnamy of the Powys Circle are suffering subsidence (see FIG. 11).
59. Whilst inhabited properties within the village are generally well maintained, other less frequently tenanted holiday properties do appear to suffer lapses in maintenance.

FIG. 13: *Ruined buildings. Left: former agricultural building at Vicarage Farm. Right: the listed Old Forge on the green.*

architectural interest. Chaldon Herring Conservation Area has poor a record of listed buildings whose special interest has been harmed by neglect. The Old Forge has been left ruinous for an extended period. Following progressive roof collapse, the structure is now both boarded and fenced off (see FIG. 13 above). Until 2011 No. 4 stood as a derelict shell for several years, and suffered extensive loss of historic fabric. The building has recently been brought back into use. The Old Farmhouse at Grange Dairy likewise stood derelict for some time before being demolished during the 1990s.

Encourage rehabilitation of the Old Forge: Rehabilitation of the Old Forge would enhance the appearance of the conservation area and provide a future for this listed building.
