# Coombe Keynes Conservation Area

## Appraisal document

**Adopted Document**

**October 2015**

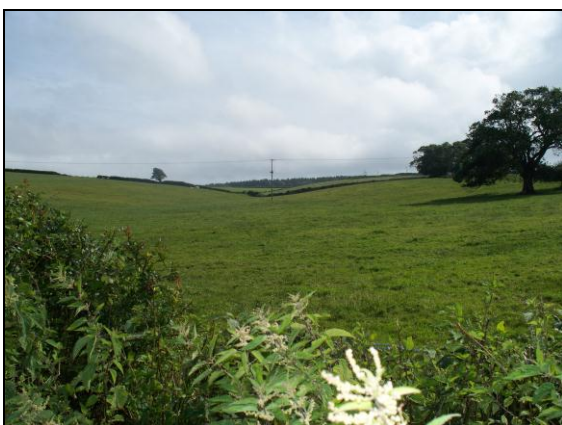
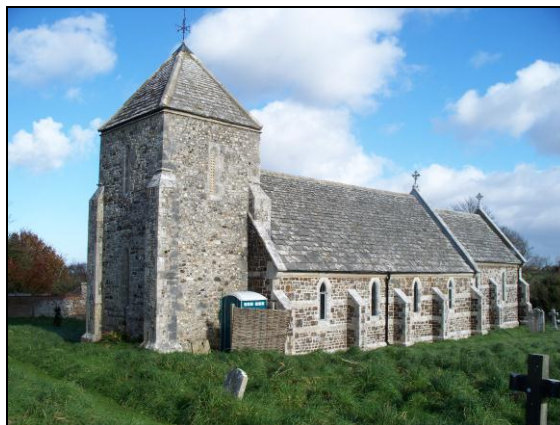
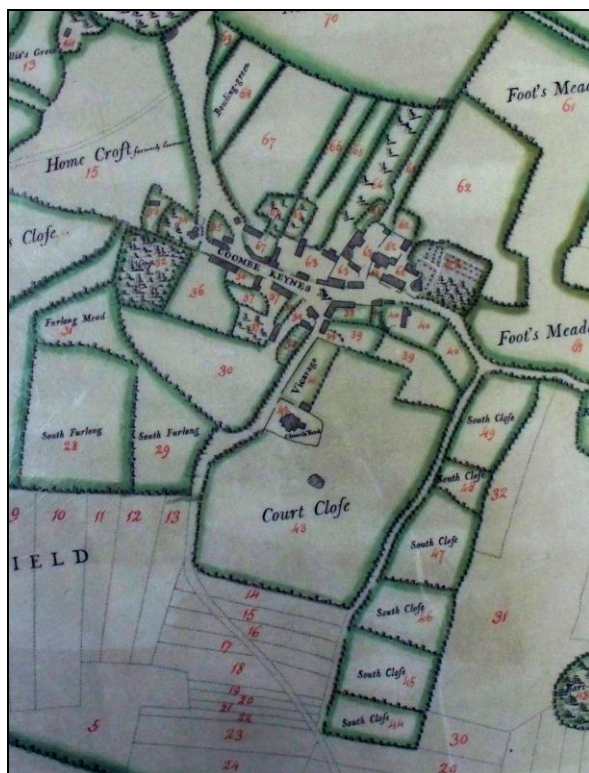
**FIG. 1:** *The medieval village. The former parish church (top right), whose tower dates to the thirteenth century, once stood closer to the centre of the village. During the medieval period a lane ran along the coombe immediately east of the modern village (top left), with houses and enclosures on the west side, and enclosures on the east. The 1770 Estate plan of the village (bottom – D/WLC/P1.5 courtesy of Dorset History Centre) shows that hedged boundaries and a track existed here many years after the houses were cleared. Following removal of hedgerows little visual evidence now remains, though the archaeological value of the site is recognised in its scheduling. Note strip fields south of the village – a vestige of the medieval open field system.*

13. The village is located within agricultural land between Wool and West Lulworth. It stands on gently rising ground, just west of the dry coombe from which its name is derived (see FIG. 1).

17. During the medieval period, and probably prior to the sharp decline in population caused by the Great Plague of 1348, the village extended further to the east of its current position (see FIG. 1 above). Though ploughing and the removal of hedgerows have removed many physical clues, the traces of house platforms, lanes and enclosures are recorded over an extensive area within the fields immediately south and east of the church, and east of East Coombe Farmhouse. Consideration of the former extent of the village partly helps to explain the detached position of the church, which would have been more integrated historically.

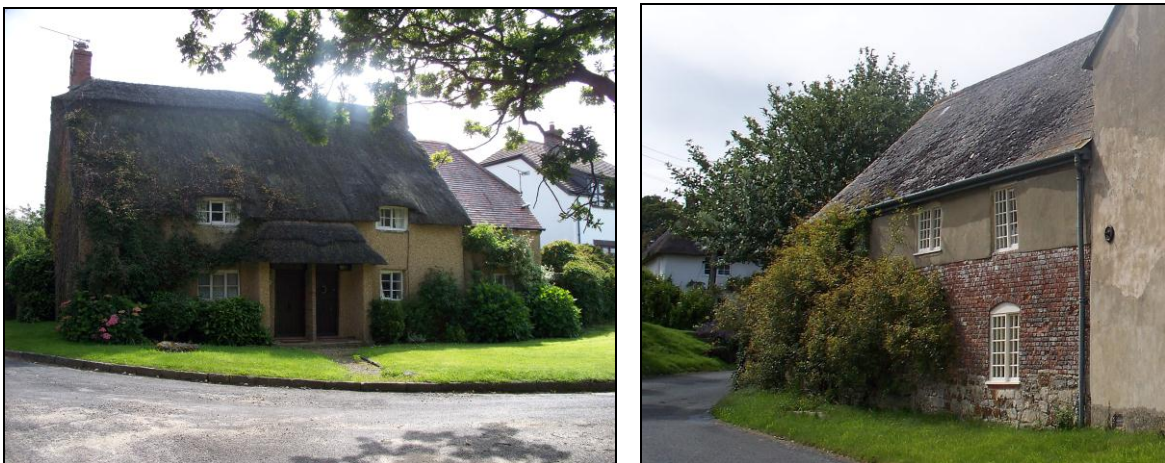
**FIG. 2:** *Buildings of 1600-1700. Left: Nos. 7/8, originally a single dwelling. Right: the original part of West Coombe Farm.*

20. Nos. 7/8, which was originally a single property, were also built during the seventeenth century, whilst the rear wing of West Coombe Farmhouse, which represents the original part of the building, was probably built at the very end of the period (see FIG. 2 below).

26. The majority of domestic buildings within the conservation area stand at two storeys, though No. 10, and perhaps also the original wing of West Coombe Farmhouse (see FIG. 2), were raised from a single storey historically. No. 7/8 provides an exception to the rule, standing at one and a half storeys. Though a number of converted agricultural structures now in domestic use have a single

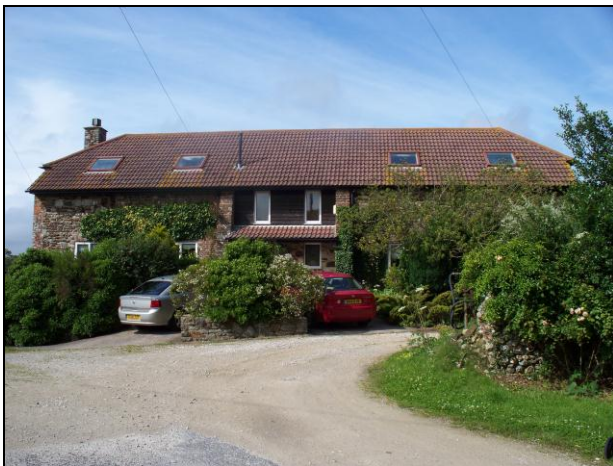
**FIG. 3:** *Barn conversion. A high proportion of the buildings in the conservation area are converted agricultural structures. These include Red Roof Barn. Much of the functional character of these buildings has been lost through over domestication of appearance and setting.*

23. The twentieth century saw a transformation in the character and function of the village from an agricultural to a residential settlement. A wave of barn and other agricultural conversions took place during the mid-1970s, some of which appear overly domestic in their features and landscaping (see FIG. 3). Development of houses on the south side of the village occurred during the 1970s and 80s, occupying the sites of two sets of buildings which had disappeared earlier in the century. Other structures shown on earlier maps stood east of Odd Nod and to the north east of East Coombe Farm. It is unclear at what point these were removed. Holy Rood Church became disused in 1967.

48. The insertion and blocking of openings within converted historic agricultural buildings has generally domesticated their appearance, and harmed their historic functional character. Former threshing barns such as Red Roof Barn (see FIG. 3) and Dairy Barn have been most significantly affected.

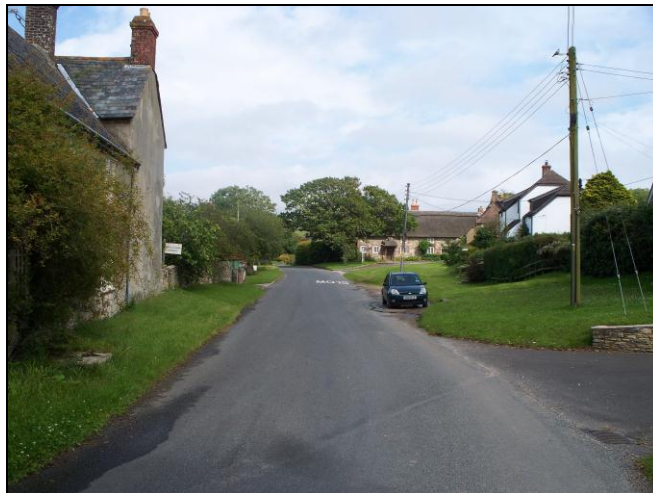
**FIG. 4:** *View through the village from the west. Note the broad verges.*

24. A single through road runs east-west through the village. This passes through a large, roughly triangular space, composed of a green and verges, and around which the majority development is arranged. From the broadest western end of this space, a further lane runs south to the church, reverting to the status of a farm track beyond this.

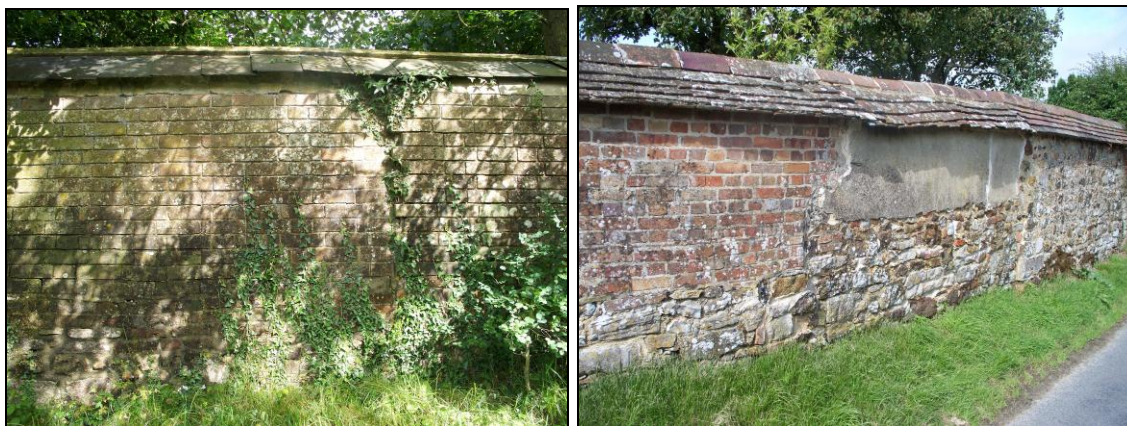
**FIG. 5:** *Boundary walls. Left: Old Parsonage, pale brick with stone base and slate with stone ridge coping. Right: East Coombe Farm, wall containing elements of reused brick, stone and tile alongside cob, with a tiled coping.*

28. A large proportion of historic domestic buildings face directly onto verges, the latter cultivated as unenclosed gardens around the green. Walls enclose the yard and garden frontages of West and East Coombe Farmhouses, and part of the Old Parsonage (see FIG. 5 below). These walls are of interest for the variety of materials they contain, and style of coping they employ. Those at East Coombe Farmhouse and the Old Parsonage are 'roofed' much in the cob building tradition, and those at West Coombe Farmhouse carry a simple half round clay coping.
29. Hedgerows play an important role in providing enclosure around the fringes of the village, helping the settlement to merge into the broader agricultural landscape. Hedges have also been favoured in modern development on the south side of the village. Close boarded fencing at Rooks appears intrusive in the rural context.

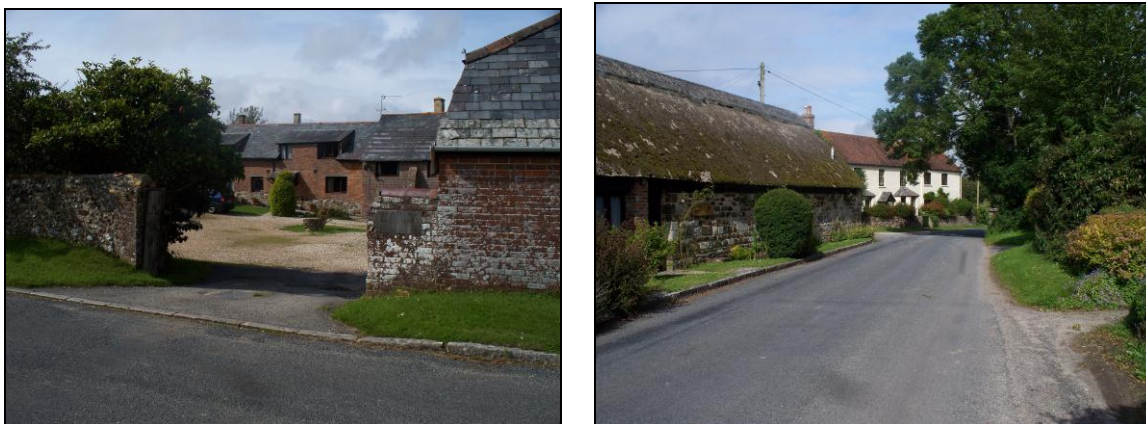
**FIG. 7:** Views around the conservation area. Left: View into the former farmyard at West Coombe Farm. Right: Looking east from the centre, East Coombe Farmhouse closes the view.

30. The grouping of thatched cottages around the green is particularly attractive viewed from the west and from Church Lane (see FIG. 7). The quality of views to the west of the green is spoiled by modern development, though West Coombe Farmhouse provides a point of interest. Looking east from the green, East Coombe Farmhouse plays an attractive role in partially closing the view (see FIG. 6), whilst a similar role is played by April Thatch at the west end of the village. Glimpses into spaces which formerly served as farm yards provide interest on the north side of the village (see FIG. 6).

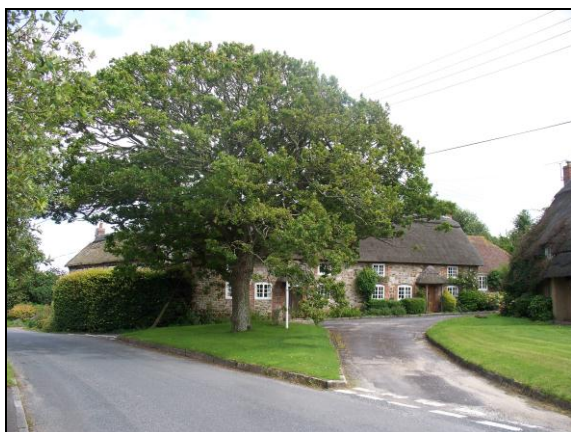
**FIG. 7:** The green. The triangular space provides a focal point in the composition of thatched cottages at the 'centre' of the village. The oak tree is a notable feature.

31. The oak that stands on the green is the principal tree of note within the conservation area (see FIG. 7 below). This plays an important role in views around the centre of the village. Trees and shrubs otherwise line Church Lane and the entrance into the village from the west, and generally provide a green backdrop and setting for buildings.

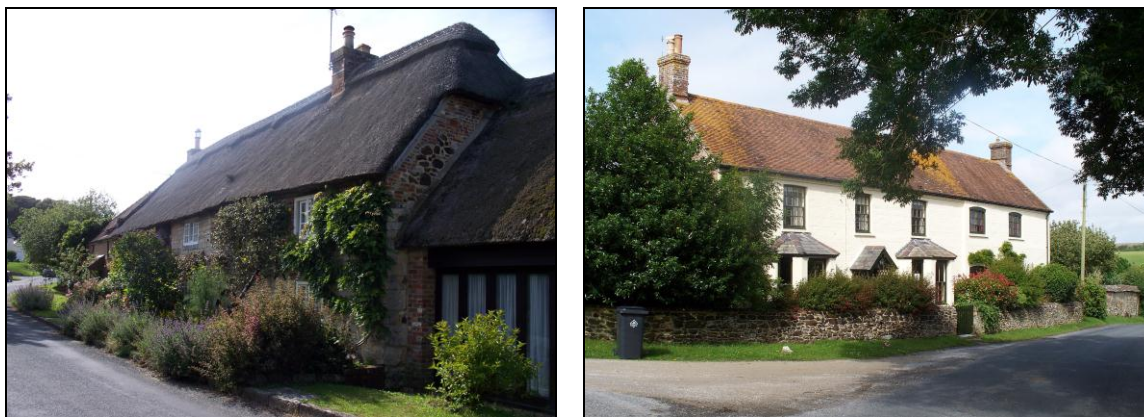
**FIG. 8:** *Architectural character. Left: The Long House exhibits characteristics of the historic local vernacular. Right: East Coombe Farmhouse demonstrates more standardised nineteenth century style.*

37. The majority of historic domestic buildings within the conservation area may be described as 'vernacular' in their architectural character (i.e. built according to local tradition). These buildings are generally make use of similar materials and elements, though their composition is informal. Greater formality exists in buildings dating from the nineteenth century onwards, whose architectural style is more recognisably influenced by contemporary fashion. This is clearly seen at East Coombe Farmhouse (see FIG. 8), the east range of West Coombe Farmhouse, and to a lesser extent the Old Parsonage.

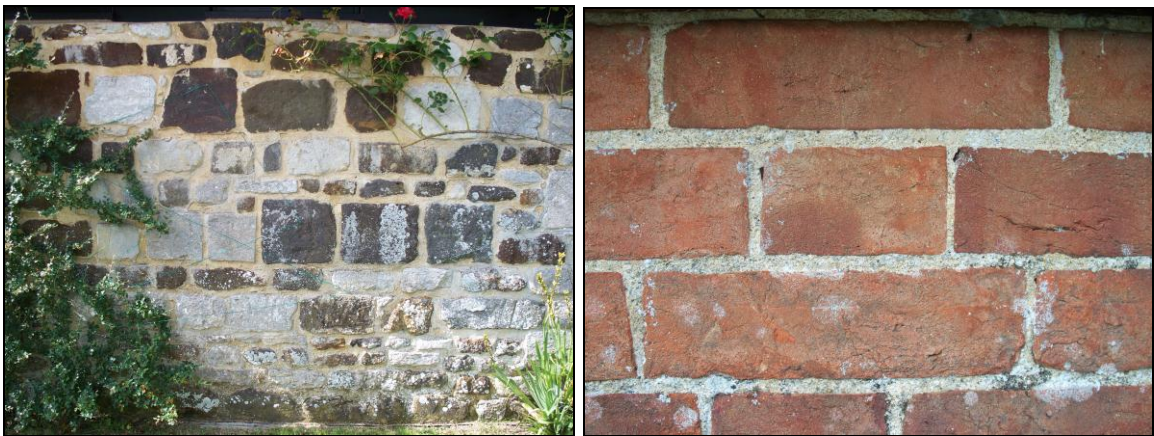
**FIG. 10:** *Walling. Left: Heathstone and limestone masonry seen in the walls of the former barn alongside the Long House. It is likely that this high quality material was salvaged from elsewhere. Right: It is likely that brick seen in the walls of agricultural buildings fronting the main street was manufactured at works historically located just west of the village.*

38. Stone was a favoured building material in the village up until the early nineteenth century, and thus plays an important role in characterising vernacular development. Heathstone, limestone, and less frequently flint, were all utilised, most often randomly mixed (see FIGs. 5 and 9). As noted above, the mixing of material, together with the presence of carved and block stone within buildings of relatively humble status, suggests that the supply of building materials was both inconsistent, and at least partly derived from demolished buildings (Bindon Abbey and structures in the abandoned part of the village are obvious candidates). Interestingly this pattern is also seen in the thirteenth century tower of the church, suggesting that the practice of recycling had a much longer history in the village.

40. Reading clay is available within the immediate vicinity, and was exploited by a small brickworks west of the village from the mid-nineteenth to the twentieth centuries. Locally produced orange-red bricks (see FIG. 9) can be seen around the village, predominantly used in construction of agricultural buildings, outbuildings and boundary walls of nineteenth century date. It seems likely that brick was manufactured on a more ad hoc basis prior to this time, as may have been the case for the early brickwork seen in the original wing of West Coombe Farmhouse. Aside from its use as a principal building material, brick also finds use in forming openings within buildings of stone masonry construction.
