East Lulworth Conservation Area

Appraisal document

Adopted Document

October 2015

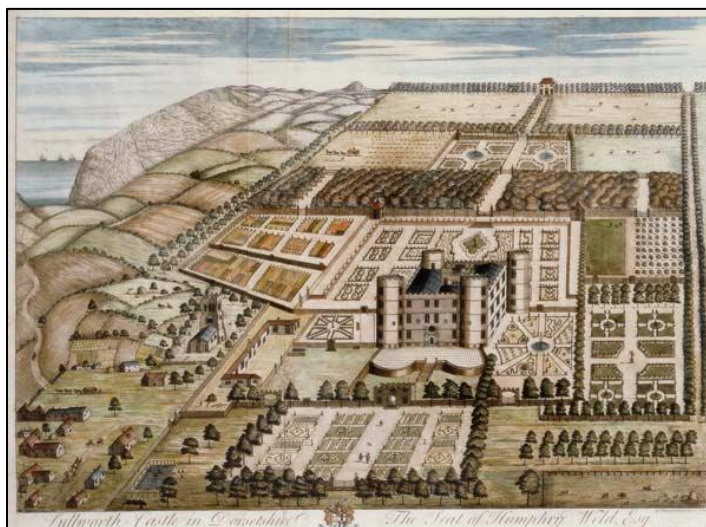
FIG. 1: *Lulworth Castle and gardens c.1721. Whilst not at all cartographically accurate, the view provides a good impression of the organisation, design and use of the park at this time. The formal gardens and village are shown as they existed prior to the remodelling, clearance and landscaping which took place in the late eighteenth-early nineteenth century. Deer still occupy the two fields to the north showing that the original function of the park continued, albeit on a lesser scale than previously.*

park damaged. With the loss of Bindon House, Lulworth Castle was transformed from hunting lodge to house, and East Lulworth once again became the principal seat of the estate. It is unclear what immediate implications this change of role had upon the character and use of the park, though by 1721 (see FIG. 1) extensive formal gardens had been laid out around the castle, with deer restricted to a relatively small portion of the park.

23. Other buildings within the conservation area dated to the seventeenth century include the distinctively designed Park Lodge (one time dower house which has held various other functions, and whose name may recall an earlier hunting lodge on or close to the site), Manor Cottage (see FIG. 3), Nos. 21/22, 23, 27, 14-16 Cockles, No. 39 Mount Pleasant, elements of the castle stables, and Wareham Lodge. The latter is thought to be contemporary with the castle and portrayed in its original position on the 1721 painting reproduced in FIG. 1.

24. Though the dispersed pattern of development which currently characterises the village was established by at least the seventeenth century, the bulk of the village lay to the south and east of the church until the late eighteenth century. The painting of 1721 (FIG. 1) shows the castle and its gardens, including the adjacent parish church and village, whilst the village is more clearly shown in the 1770 survey of the estate (see FIG. 4 below).
25. Buildings constructed or finding origin in the first two thirds of the eighteenth century (and evident on the 1770 estate map) include Nos. 20, 18/19, 17, 24, and No. 25 Cockles, Woodside Lodge, Nos. 1-2, 3/4, 6-8, the Weld Arms, 40 Mount Pleasant, and Common Hill Cottage. No. 26 Cockles meanwhile is dated to the late eighteenth century.

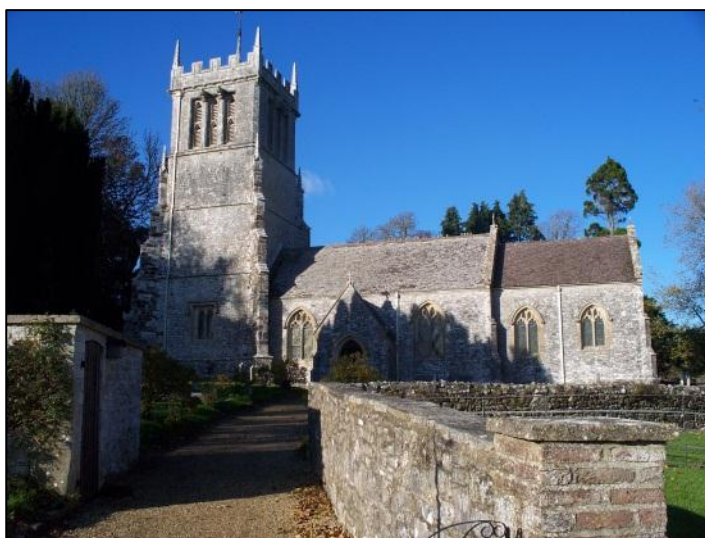
FIG. 2: *St. Andrew's Church. The fifteenth century tower is of note, the rest of the church dates to the late nineteenth century. The de Newburgh's manor house is thought to have stood close by.*

19. Whilst most of the parish church is of Victorian date, the tower was constructed during the late fifteenth century (see FIG. 2).

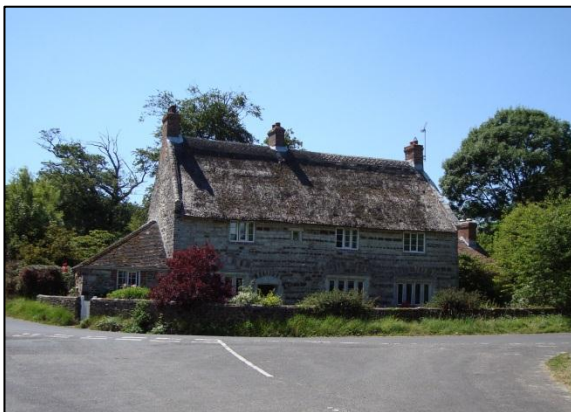
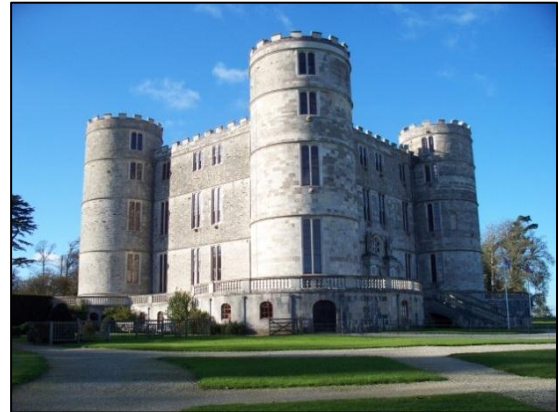
FIG. 3: *Buildings of the seventeenth century. Left: Manor Cottage, which is shown on the 1770 map in FIG. 4. The decorative banding of limestone and heathstone is especially notable. Right: the castle, originally built as a hunting lodge, became the dwelling of the Welds in the mid-seventeenth century.*

64. Heathstone – iron cemented sandstone generally found in heathland areas of the District – sees frequent use in the rubble walls of buildings and boundaries. The attractive orangey colour is used to decorative effect at Manor Cottage (see FIG. 3) and No. 21/22 Cockles, where it is banded with limestone. Clare Towers (FIG. 12 below) is chiefly constructed from the material, as too the flanking buildings and towers alongside North Lodges. Substantial amounts of heathstone rubble were used in construction of the park wall where it generally provides the original lower portion (raised in brick adjacent to the roads), and other boundaries, whilst large cut blocks are visible in the buttresses of the church tower.

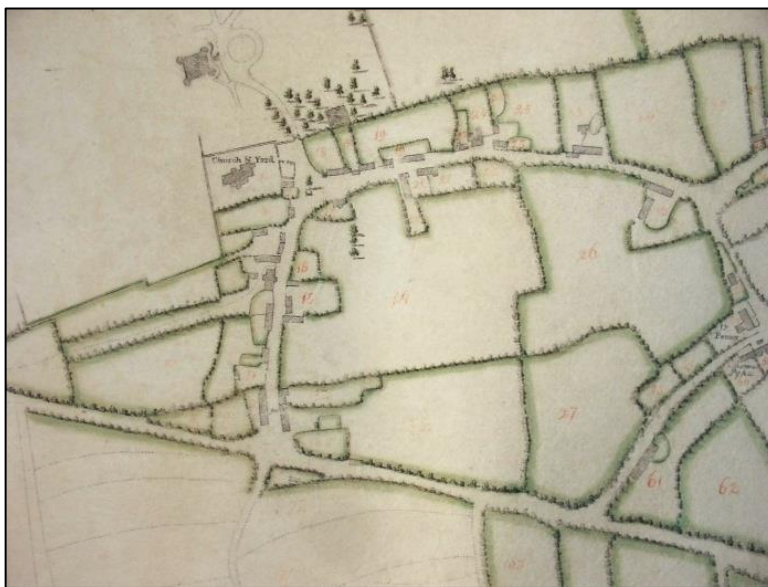
FIG. 4: *The core of the village in 1770, shortly before its clearance (D/WLC/P1.7 Courtesy of Dorset History centre). Most of the buildings, boundaries and the road serving them were cleared towards the end of the century to create the park. Aside from the castle, church and stables, surviving buildings shown include Manor Cottage, The Weld Arms and Nos. 21/22 bottom right.*

the principal part of the village (shown in FIG. 4), and then again when heightened through addition of brickwork above the original heathstone/limestone base. The visual relationship between Nos. 14-16 and boundary of the park is a particularly poignant one, as these cottages once lay at the edge of village core. During the medieval period the park pale (earth bank topped by a wooden fence) around the deer park would have made a similarly bold social statement given the exclusivity attached to the hunting of deer at his time (emphasised by the fact that most of contemporary Purbeck was a royal hunting reserve). The earth bank still survives along much of its original length, and in places can be viewed running directly behind the later park wall.

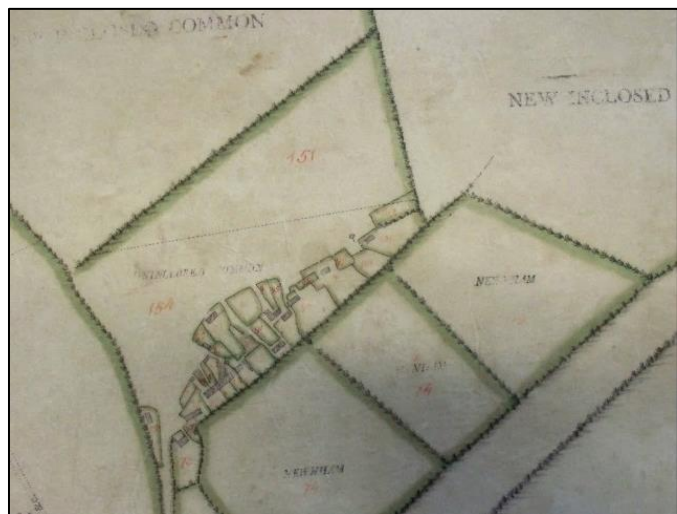
FIG. 5: *Houses at Common Hill, later Mount Pleasant (D/WLC/P1.7 courtesy of Dorset History Centre). The 1770 estate plan shows a tight cluster of irregularly laid out buildings. Drawn shortly after the enclosure of East Lulworth Common, the houses are shown bordering a scrap of "unenclosed" land, whilst to the north and east new fields have been formed. Four of these buildings survive, one ruinous.*

28. In 1770 the area currently known as Mount Pleasant, but at that time as 'Common Hill', sat on the edge of what had been the East Lulworth Common (see FIG. 5 above). A Bill of 1761 allowed the common to be enclosed with the bulk of land assigned to the Welds. A surviving fragment was used for the construction of Nos. 32-5 and adjacent buildings, though even in 1840 small scraps of unenclosed common are recorded as surviving. Of these, the triangular 'green' seen upon entering Mount Pleasant (see FIG. 10), and the broad verge to the front of Nos. 32-5 remain as relics. The 1770 map of the common labels dwellings at Mount Pleasant 'the common houses', and it seems credible to suggest that this was because the grouping which then existed were 'encroachments' (i.e. buildings informally constructed on common land). The position at the edge of the common, detached from the main part of the village, and the dense and irregular layout of what appear to be tiny houses, may support this theory. Estate surveys indeed confirm that the construction of dwellings on the common and 'waste' (uncultivated land) was taking place in the village during the eighteenth century.

36. As the village is composed of loosely dispersed clusters of buildings, with some significant open spaces and the odd building between, over all density is low. Within clusters however, buildings are sometimes quite closely packed, as seen at Cockles (FIG. 7 above). Similar density historically occurred amongst the 'common houses' at Mount Pleasant (see Section 3 and FIG. 5).

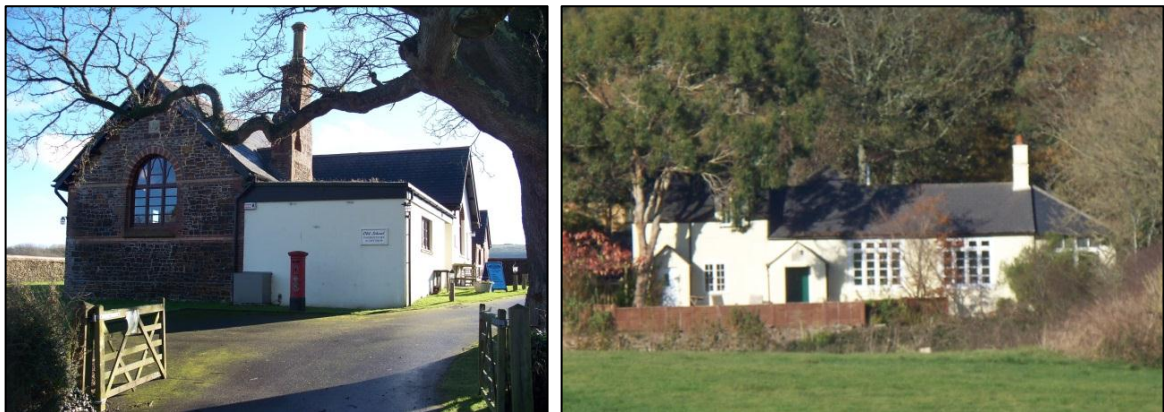
FIG. 6: *The nineteenth century schools. Unusually for such a small settlement, East Lulworth once contained two schools. Right: the Elementary School c.1840. Left: St. Mary's Catholic School c.1855.*

31. The nineteenth century saw construction of two schools (see FIG. 6), the Elementary school in 1840 (now a dwelling), and St. Mary's Catholic School in 1855 (now a shop). A catholic cemetery was established in 1860 at what was then Common Hill, but which maps subsequently labelled 'Cemetery Hill' (see 1889 OS map). It is likely that the road outside the cemetery was straightened at the same time with the scraps of common land through which it formerly meandered were enclosed. Other notable works of the nineteenth century were the gardener's cottage/lodge in the middle of the century, and rebuilding of the church in 1864.

56. The small green opposite the old post office carries the majority of street furniture found within the conservation area. Notable are the listed K6 jubilee telephone kiosk, and the finger post. A modern post mounted letter box has replaced that still located in the wall of the old post office. An Edward VII pillar box has been placed, somewhat incongruously, outside the former St. Mary's School (see FIG. 6).

62. The growing influence of national 'pattern book' styles is seen particularly in the mid-Victorian neo-Gothic of Garden Lodge (FIG. 11 below), and former St. Mary's School (FIG. 6). Further, more generic designs are seen in the twentieth century housing at Cockles and Mount Pleasant.

74. Chimneys are an important, traditional feature of the majority of domestic buildings within the conservation area, and are an architecturally important component of the design of buildings such as Garden Lodge (FIG. 11). Chimney stacks are chiefly constructed from brick, in simple form with corbelled top. Pots vary with the most interesting the tall buff octagonal pot used on the surviving chimney stack of the former St. Mary's School (see FIG. 6).

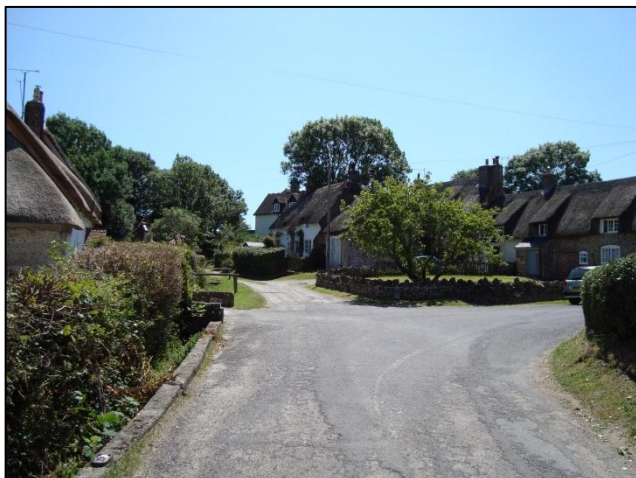
FIG. 7: *Cluster of cottages at Cockles.*

-
47. The various clusters of historic buildings within the conservation area provide attractive compositions, though where dereliction occurs (i.e. at Cockles – FIG. 7 – and Mount Pleasant) there is clear scope for improvement. The castle can be glimpsed above the trees entering the village from the east, and between the trees from the south, though is only fully appreciated close up within the park. The parish church and castle provide an attractive pairing viewed from certain angles, though the belt of *Ilex aquifolium* between detracts from this.
 48. To the south the view is dominated by the Purbeck Ridge and the prominent earthworks of Flowers Barrow hillfort. A break in the ridge immediately south of the castle opens up at Arish Mell, allowing a glimpse of the sea. The positioning of Castle House also takes advantage of this vista.

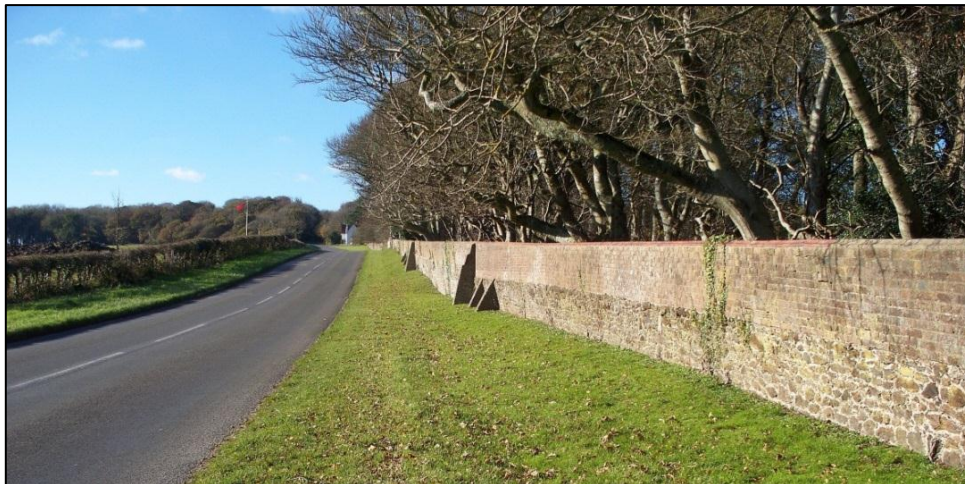
FIG. 8: *The park wall. A major feature of enclosure within the conservation area, generally built on a masonry plinth (variously heathstone and or limestone with occasional flint), raised in brick adjacent to roads.*

42. The wall is a historically symbolic feature, and though now collapsing in various places, represented a bold statement of power and social differentiation in the past. This would have been most striking on its construction following clearance of

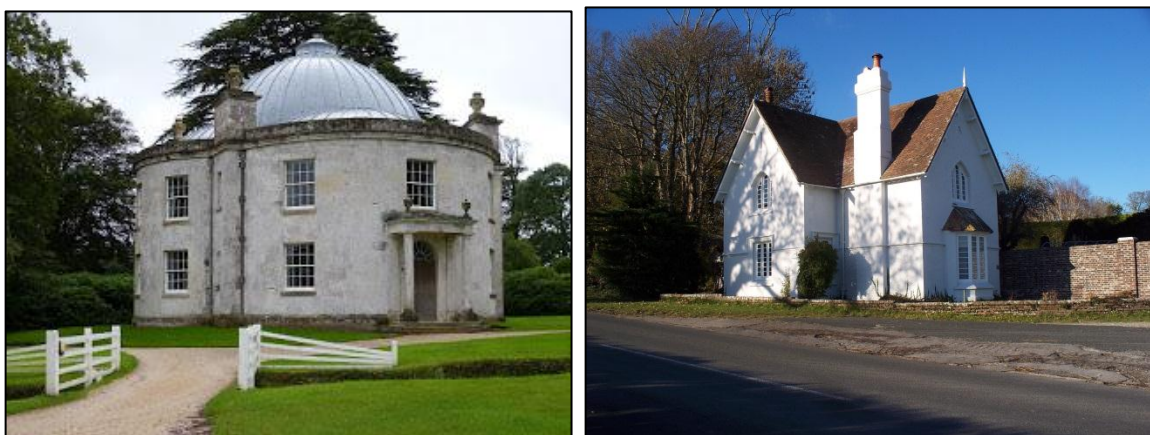
FIG. 11: *St. Mary's Chapel and Garden Lodge. The chapel (right) has the appearance of garden pavilion and stands on the edge of rolling open parkland across which North Lodges (see FIG. 12) is visible in the distance. Garden Lodge (right) has a more distinctly Victorian, neo-Gothic pattern book style.*

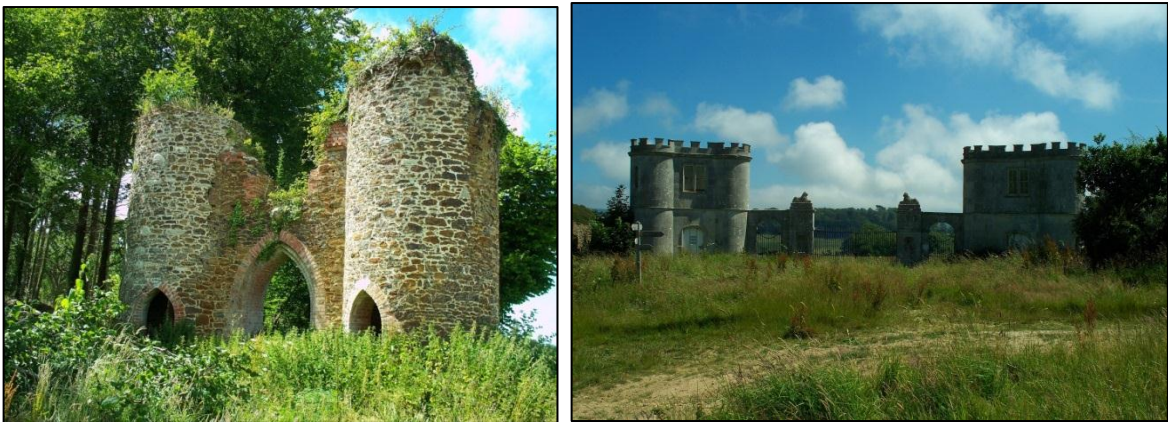
FIG. 12: *Clare Towers and North Lodges. Clare Towers (right) is a ‘Gothic’ styled northern entrance to the park, whose heathstone construction is more visible since concealing ivy has been removed. This has also clearly exposed the poor condition of the structure. Higher quality Portland ashlar is used at North Lodges to the east (right), though flanking towers and walls are constructed from heathstone. This building is also in poor condition and on the Historic England ‘at risk’ register.*

- Clare Towers (see FIG. 12): structurally unstable and partially collapsed, this former gateway into the park was covered in ivy for many years. Removal of the ivy has clearly exposed the poor condition of the surviving fabric.

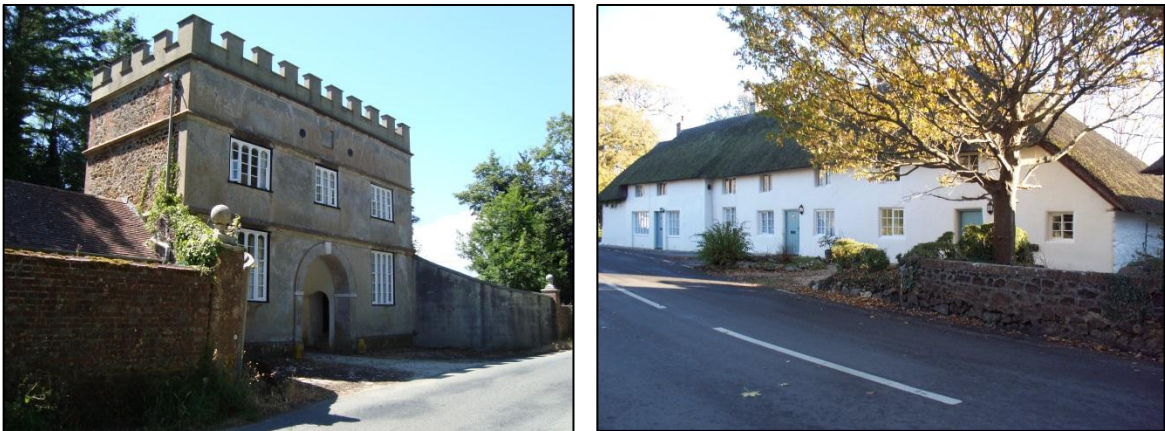
69. Whilst render generally carries no ornamentation where used to cover the wall surfaces of cottages, more formal lined out finishes (imitating ashlar stonework) are seen at the Grey House, the old rectory, Wareham Lodge (FIG. 13) and Lindens. At the Grey House the finish has been renewed in cement and the incised decoration reapplied without the usual expression of lintels. This type of finish was particularly fashionable during the early nineteenth century.

FIG. 13. *Render. Wareham Lodge (left) has a flat, formally lined out self-coloured render. This may have been introduced when the structure was moved. Nos. 6-8 (right), which includes the old post office, carries a more informal protective render more typical of the vernacular.*

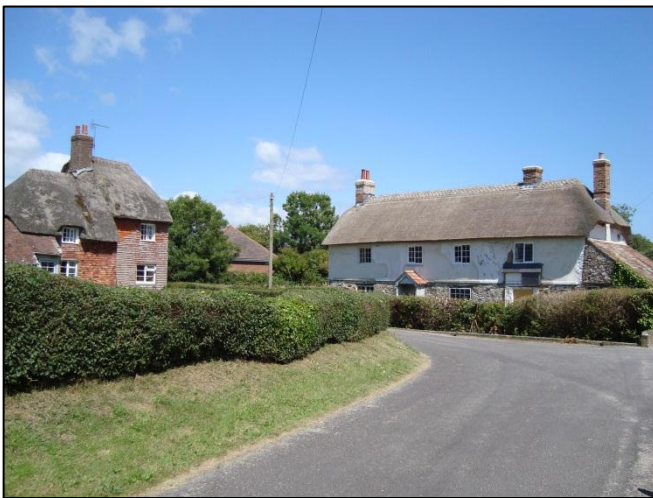
FIG. 14: Cottages at Cockles. No.17 (left) is a visually eccentric building with unusual form and varied palette of materials, including hanging tiles. Nos.18-19 (right) have a more typical form and are constructed from cob on a high rubble stone plinth.

- 18-19 Cockles (FIG. 14): consolidated externally, having become derelict after listing. Full repair and refurbishment were approved in 2010, but works have ceased. The condition of the building has again begun to deteriorate.
- Parish church: appears to suffer from dampness which has caused extensive fungal growth inside.
- Wall adjacent to the lodge at the main entrance to the park: shows a series of vertical cracks and movement.
- Entrance to the park at Shaggs: partially overgrown with ivy and buddleia, each of which can cause severe damage to brickwork.

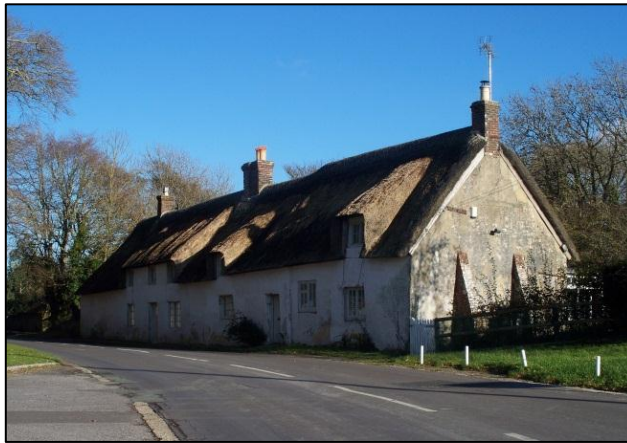
72. The vernacular (traditional) roofing material is thatch. The majority of historic roofs in the village have been renewed with modern water reed coverings, though investigation of historic coverings at 18-19 Cockles prior to their removal demonstrated that straw was used here historically.
73. Clay tiles are the second most frequent roofing material, and it seems likely that much of the material used within the village was manufactured on the estate at Coombe Keynes brick yard and tilery. Stone easing courses are seen at Park Lodge and 32-35 Mount Pleasant. These were popular during the late eighteenth century, and are seen on buildings of similar date and varied status elsewhere in the District (particularly Wareham). Use usually implies that the original construction lacked gutters given the tiles assisted in shedding rainwater clear of the eaves.

FIG. 15: Nos. 14-16 Main Road. As elsewhere in the village the thatched roof has been renewed. Old photos show a heavy accumulation of what was almost certainly straw thatch, within which the dormers were far less prominent.

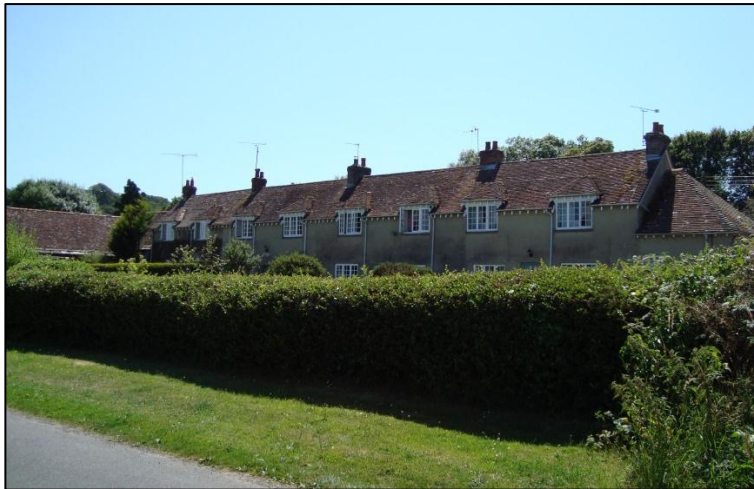
FIG. 16: Nos. 51-54 Shaggs. A distinctive terrace of cottages carrying the date stone 1792.

27. In comparing the 1770 estate map with the 1840 tithe map, it is interesting to note that, despite the clearance which took place, relatively few buildings were constructed in the eastern part of the village during the period. Contrary to the claim often made therefore, the village was not simply 'moved' to the east following clearance, given that most of the buildings here already existed and were separately occupied. Rather, a more dispersed replacement of housing is likely to have taken place, and may be evident in late eighteenth century terraces built at Mount Pleasant and Shaggs, where Nos. 32-37 (see FIG. 15), carry the date stone 1793, and Nos. 51-54 (see FIG. 16) carry the date stone 1792.

- *The park wall.* The park wall is the most substantial built feature within the conservation area and an integral component of the park. Whilst sections of the wall adjacent, and attached to the main entrances are formally listed in their own right, and the whole circuit is not.
- *Cottages at Shaggs.* (FIG. 16 below) Carry the date stone 1792, making them contemporary with the listed terrace at Mount Pleasant and the landscaping of the park. A range of agricultural/industrial buildings are attached. Given the date and associations it is unclear why the buildings are not listed.
- *K6 telephone kiosk opposite the old post office:* The call box is a Jubilee model (used 1936 -1955 in the UK, and overseas), its position directly related to that of the former post office. This kiosk is currently minus its door, the latter having only been recently replaced after the original was removed.

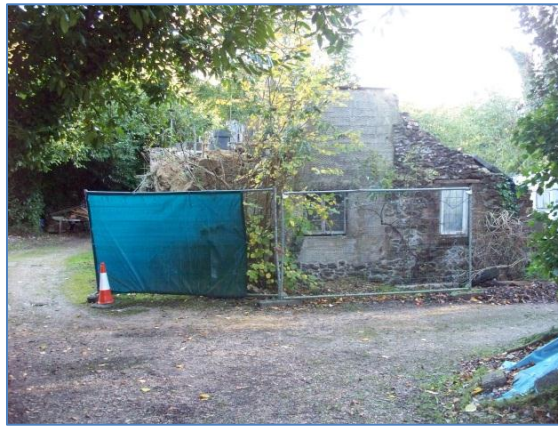
- 37 Mount Pleasant: this cottage has become severely ruinous since listing and has no roof. It is unclear how much historic fabric survives.
 - 32 Mount Pleasant (FIG. 18): a decayed shell for well over a decade, the building is currently undergoing refurbishment.

FIG. 18: *Buildings at risk. No. 37 Mount Pleasant – little of this listed building appears to survive.*
