Wool Conservation Area Appraisal Document

Adopted Document

February 2012

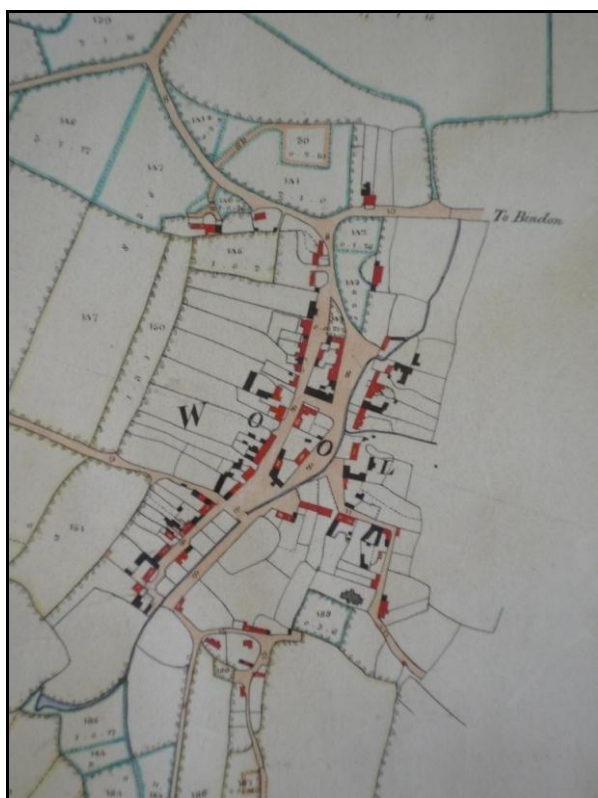
FIG. 3: 1771 Map of Wool. (Dorset History Centre). The red colour denotes dwellings and black denotes farm and other buildings

The earliest map of Wool available at the Dorset History Centre dates to the latter half of the 1700s (see FIG. 3).

FIG 4 shows little difference from the 1771 map in FIG. 3 above in terms of morphology of the village. However, the 1841 map hints towards the instalment of the railway line, which is known to have been completed in 1847 (Brown, 1970).

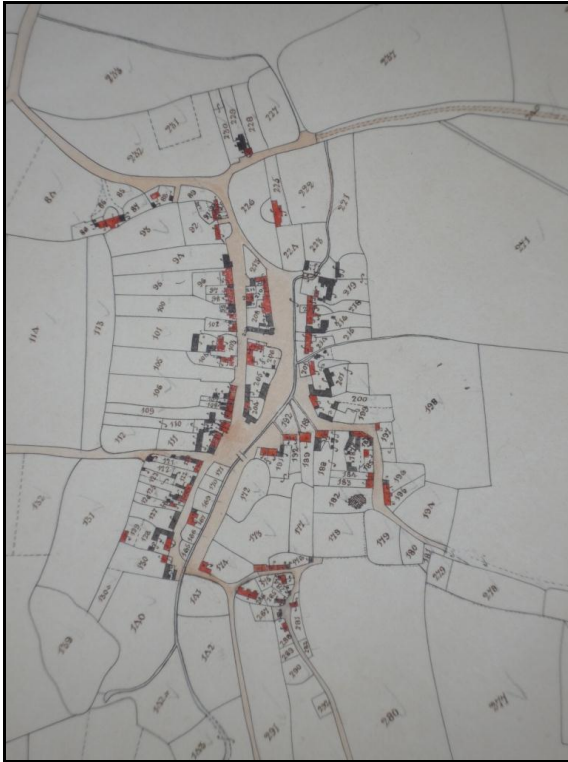
FIG. 4: Nineteenth Century Maps of Wool. Left: 1832. Right: 1841. (Dorset History Centre).

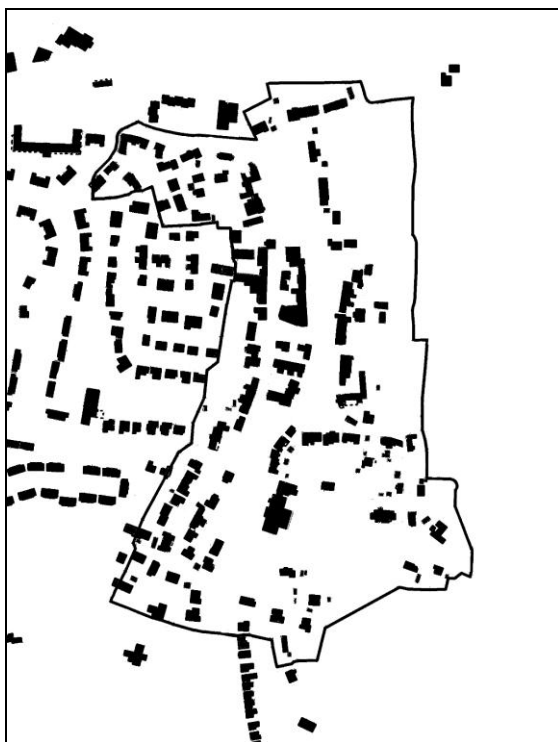
FIG. 6 below is a figure ground analysis with the conservation area boundary outlined and illustrates the building density and street pattern.

FIG. 6: *Figure ground analysis.*

Overall, the character of the conservation area is one of tight grain at the centre, radiating out to less tight grain with more openness.

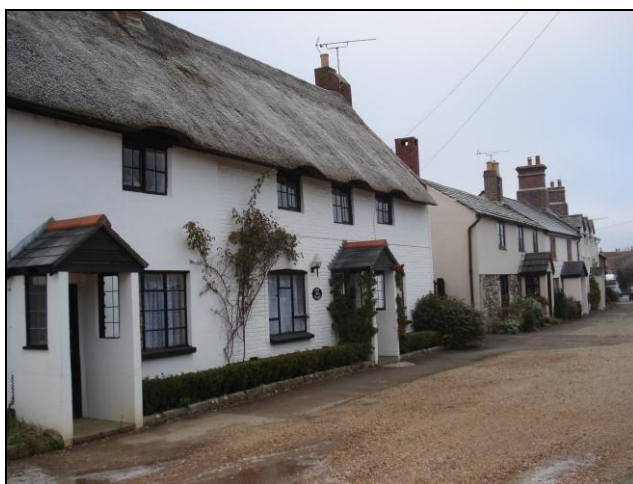
Buildings within the conservation area are predominantly 2 storeys high, with a small number of single storey buildings and domestic outbuildings. There are only two buildings of 3 storeys - the Black Bear and the Church of the Holy Rood – the latter being the tallest building in the conservation area (particularly noticeable as it sits atop a hill). Bungalows are an intrusive residential form.

FIG. 7: *Two storey buildings are the most common height in the conservation area.*

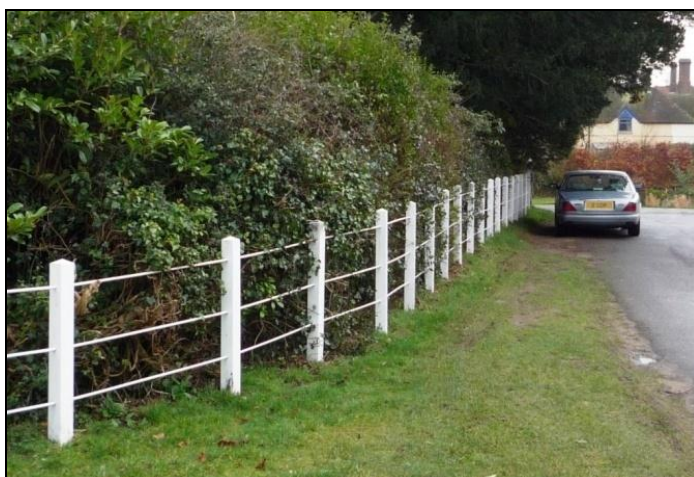
There is no evidence from available historic photographs that a particular local vernacular boundary treatment existed. Perhaps the grander houses may have had wrought iron railings on the frontage, such as today in front of Manor Farm in Spring Street (see FIG. 8 below).

FIG. 8: *boundary treatment at Manor Farm, Spring Street*

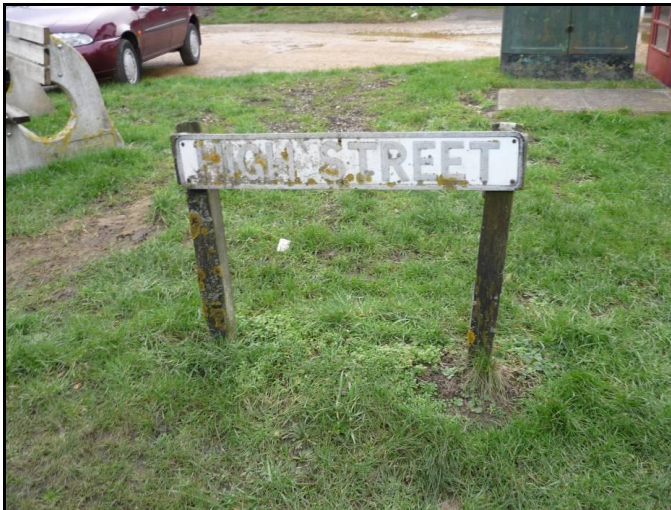
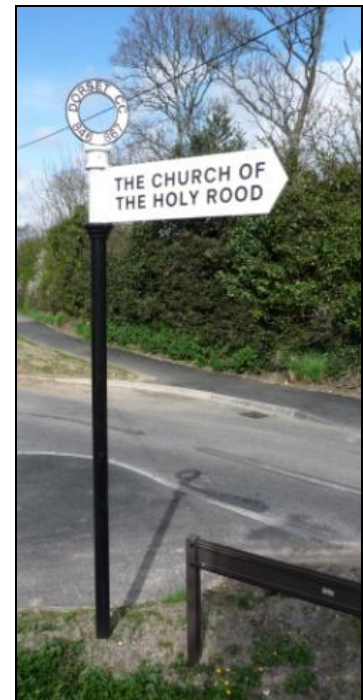
Different signage creates positive and negative features of the street scene, as illustrated by FIG. 10 below. On the left is a lower quality and poorly maintained street naming sign whose purpose is to label the principal thoroughfare through the conservation area. These should be better maintained. Adjacent is a more traditional style directional sign, which appears high quality. In the interests of consistency, the opportunity should be taken to use more of this traditional type of signage for directional signs.

FIG. 10: *The poorly maintained signage on the left detracts from the quality of the public realm. The cast iron finger post on the right is attractive. Note the ordnance survey reference on the upper cast iron ring.*

Manage and maintain street furniture: Some of the signage is poorly kept and could benefit from replacement or at least cleaning. The more traditional style signage is more aesthetically pleasing and in keeping with the rural feel of the village and should be encouraged. Other street furniture in the form of lighting appears too 'urban' and an alternative could be beneficial. The clutter caused by telegraph poles and phone lines is unfortunate and any opportunity to reduce this appearance should be taken.

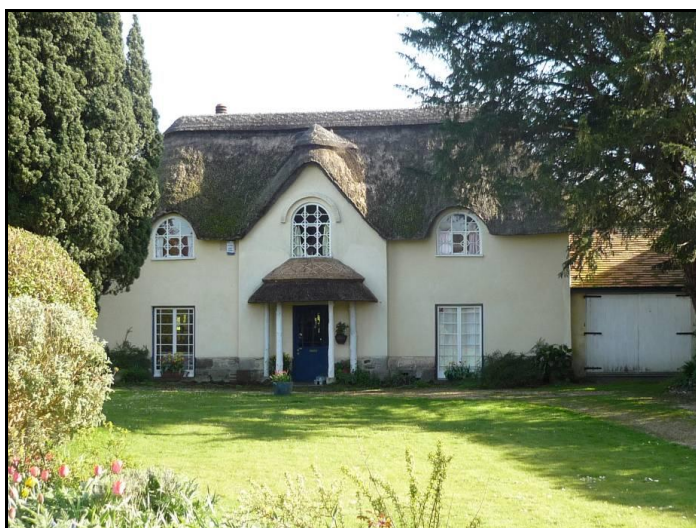
FIG. 11: *Regency Cottage, Church lane. Cottage Orn  style.*

There is a mix of architectural styles in the conservation area. The Church of the Holy Rood is an example of Gothic architecture from 13th Century origins; the Black Bear is an example of late 19th Century Commercial architecture; the Old Vicarage on Station Road is Victorian; and on Church Lane there is evidence of the Regency Orn  style. This particular property is an example of the Romantic version of the vernacular style and is shown below in FIG. 11. The vernacular in Wool is of two types: heathstone rubble or cob built walls with thatched roofs.

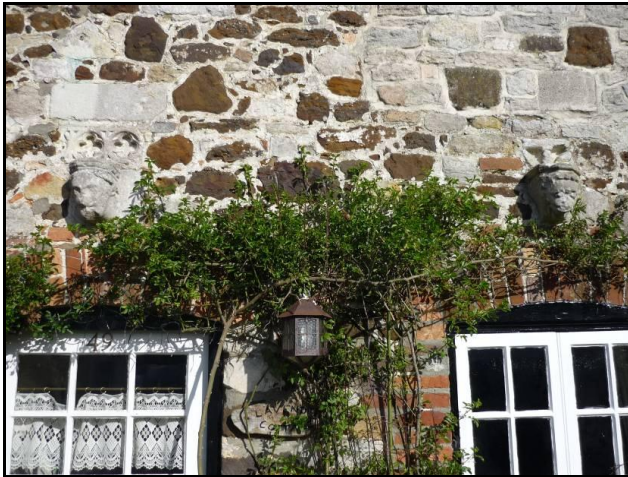
Several properties in the conservation area feature carved corbel heads incorporated into the front elevation of the property. Other dwellings have fragments of medieval stone in their frontage. These are thought to have come from Bindon Abbey.

FIG. 12: *Corbel heads in front wall of 49 Spring Street.*

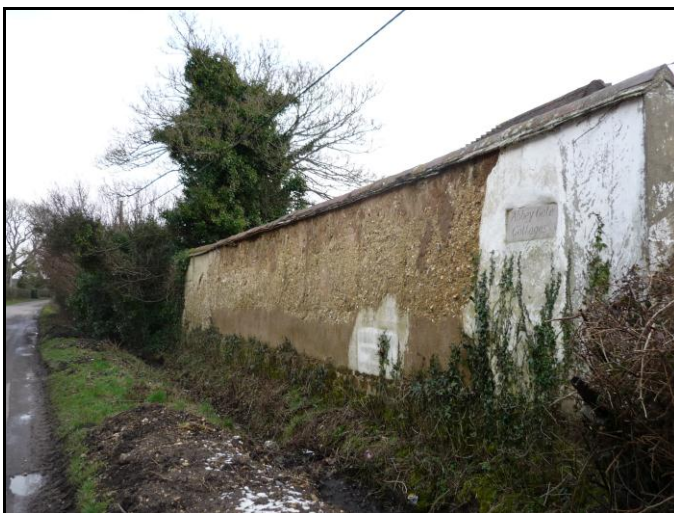
Where boundary walls are in cob, they typically stand on a brick plinth and are capped by several courses of plain clay tiles to form a miniature roof protecting the top from rainwater (see FIG. 13). Plinth courses to rendered walls tend to be painted, smooth render, or red brickwork, with the occasional stone plinth.

FIG. 13: *This cob wall in Bindon Lane stands on a brick plinth and has a tiled roof to protect it from rainwater. Unfortunately this particular example is in a state of disrepair.*

List unlisted structures and save buildings at risk: Cob walls located on Bindon Lane, Station Road and the High Street are important links with Wool's past and they are in danger of falling into disrepair. It is recommended that they are locally listed and properly maintained. Other buildings recommended for local listing are the Black Bear Pub, the simple cob outbuildings on the High Street now converted to dwellings, the pair of 19th Century dwellings at Hampton House / Hampton Villa in Duck Street, the pair of 19th Century dwellings at Holm Lea / Oddfellows House on the High Street, the Methodist Church on the south side of Station Road and the telephone box on the High Street.

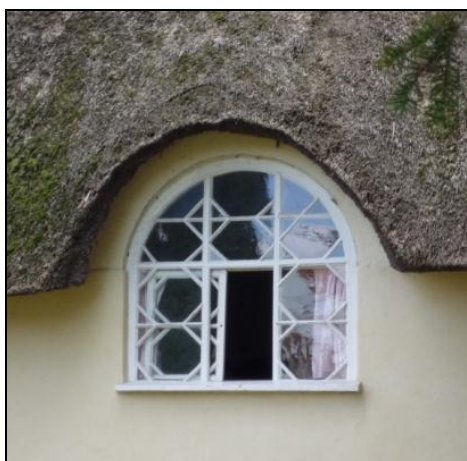
One of the prevailing features of the conservation area is casement or horizontal sliding sash timber windows. Some frames are flush with the outer walls and some are set in and the result is that cill details vary, with some relying on the timber cill integral with the frame and others on a stone sub-cill. These appear to be under threat with many being replaced in favour of UPVC. Not only is UPVC not traditional, but the design of windows often includes a top hung element, which is out of character with the sliding sash seen elsewhere.

FIG. 14: *Windows at Regency Cottage. Note the horizontal sliding sash window.*

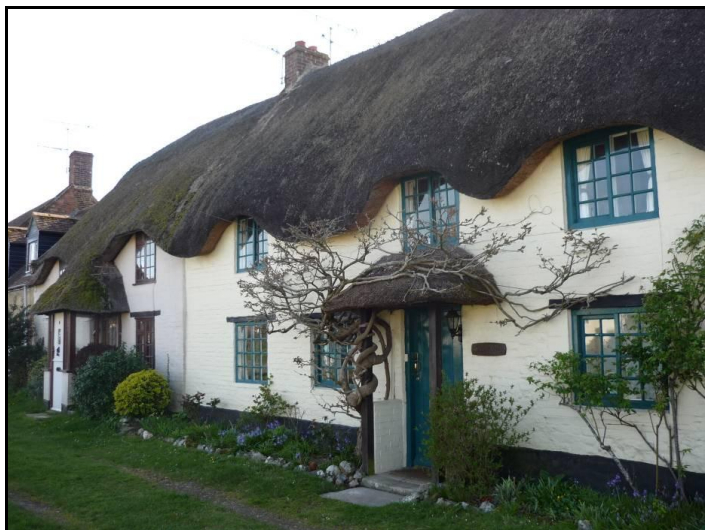
Porches formed by door hoods are common and some incorporate the thatch from the main roof and feature planting that climbs up the supporting posts (see FIG. 15 below). This is a delightful feature that adds to the character of the village. Elsewhere, thatched dwellings have porches finished with slate roofs.

FIG. 15: *The plant climbers on this thatched porch in Spring Street are a delightful feature that helps animate the street scene.*

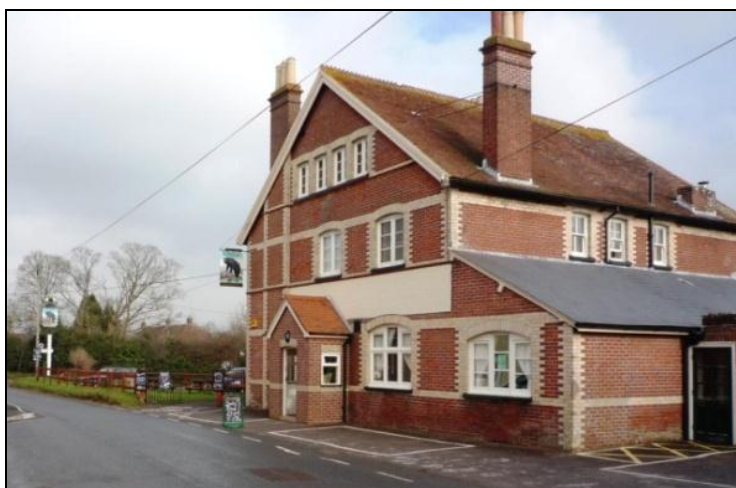
FIG. 16: *The Black Bear Pub – prominent when entering the village from the north.*

The Black Bear is visually prominent at the entrance to the northern part of the conservation area and is an attractive late 19th Century commercial building. It is typical of many Hall and Woodhouse pubs in rural Dorset, any number of which are now closing and being reused for residential purposes, but this example appears relatively unaltered. It retains its timber sliding sash windows and slate roof and has impressive chimney stacks.

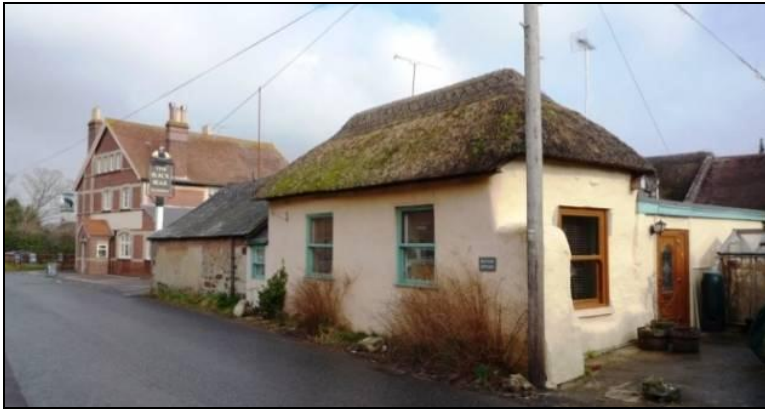
FIG. 17: *Converted simple cob outbuildings abutting the High Street, one of which has a thatched roof. Such buildings reinforce the character of this part of the conservation area.*

Also of interest are the two small, converted outbuildings on the High Street pictured in FIG 17. Both are of cob construction - one with a thatch roof and the other with slate. They are important remnants of the curtilage buildings associated with the original farm and listed buildings adjacent. They are visually and historically important buildings, the loss of which would be regrettable.

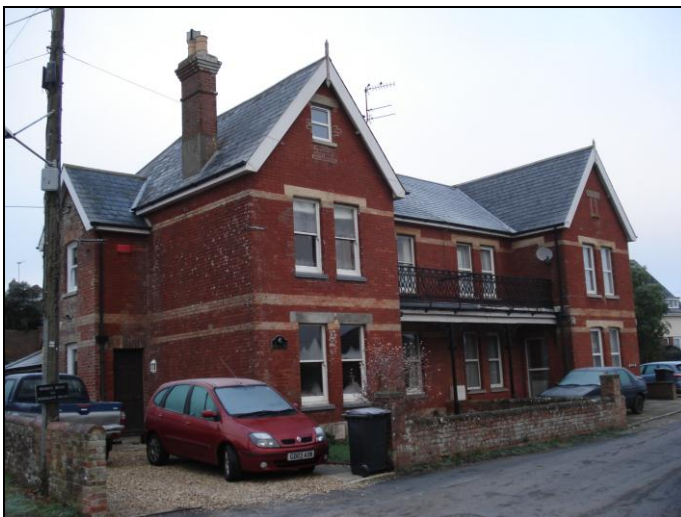
FIG. 18: *Hampton Villa and Hampton House. An attractive pair of relatively unaltered houses on the western side of Duck Street. The balcony made of cast iron features some interesting detailing. The front boundary walling also remains.*

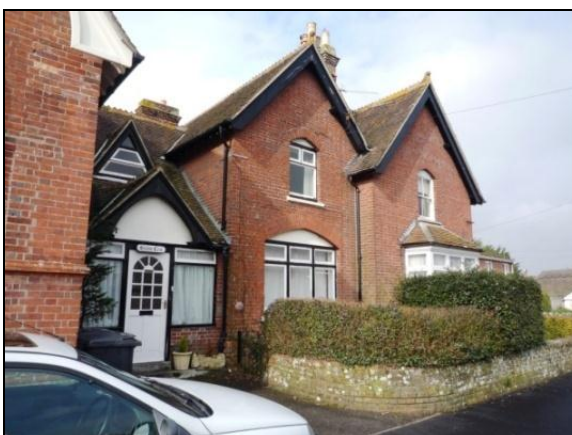
FIG. 19: *Holm Lea and Oddfellows House on the High Street are attractive semidetached 19th Century dwellings with projecting gables.*

Holm Lea pictured in FIG. 19 features an unusual but attractive triangular dormer on the front elevation. The front boundary enclosure of a brick wall is retained.

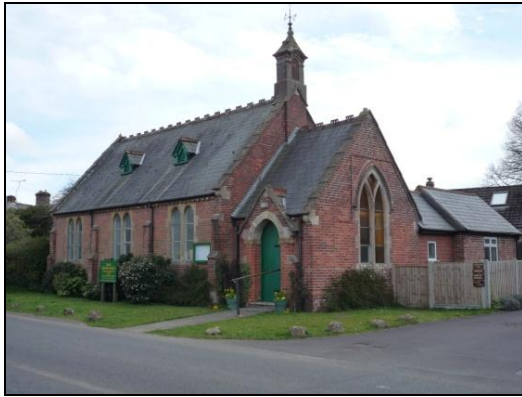
FIG. 20: *Methodist Church on Station Road, which is still in use and retains almost all of its original features.*

This is a late 19th century red brick and natural slate roof Methodist Church. It is prominent in the street scene when entering the northern part of the conservation area. It is an attractive, unaltered example of its type, retaining many of its original features using local stone window dressings and timber doors.

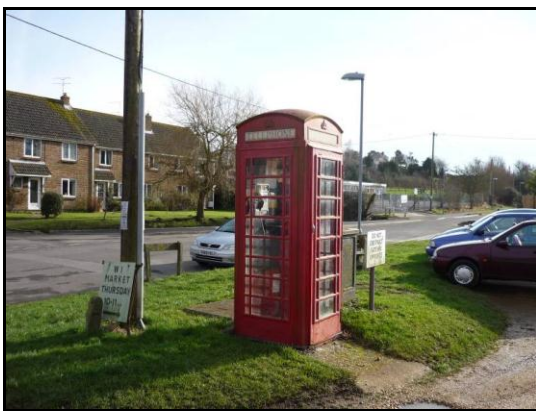
FIG. 21: *K6 phone box in the High Street. Still in use though its future remains uncertain.*

The K6 Jubilee telephone kiosk (FIG. 21) is located at the junction of the High Street and Duck Street. An increasingly rare feature in many towns and villages, this example is a positive local landmark and historic feature worthy of retention. Unfortunately the adjacent green relay box, telegraph pole and signage detract from the street scene.

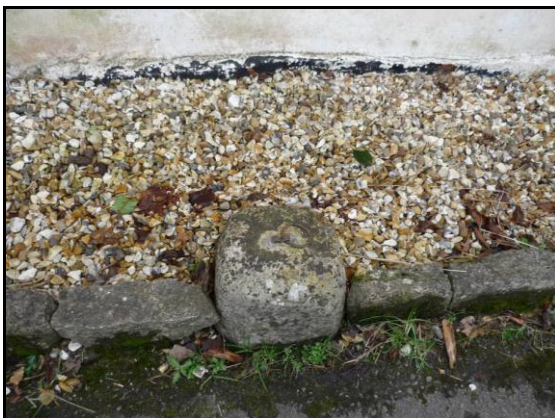
FIG. 22: *Stone to tether livestock. Located on Church Lane, an interesting detail in the street scene.*

Features such as the stone to tether livestock shown in FIG. 22 are a reminder of the village's farming heritage and are attractive details in the street scene. This particular example is located on Church Lane.

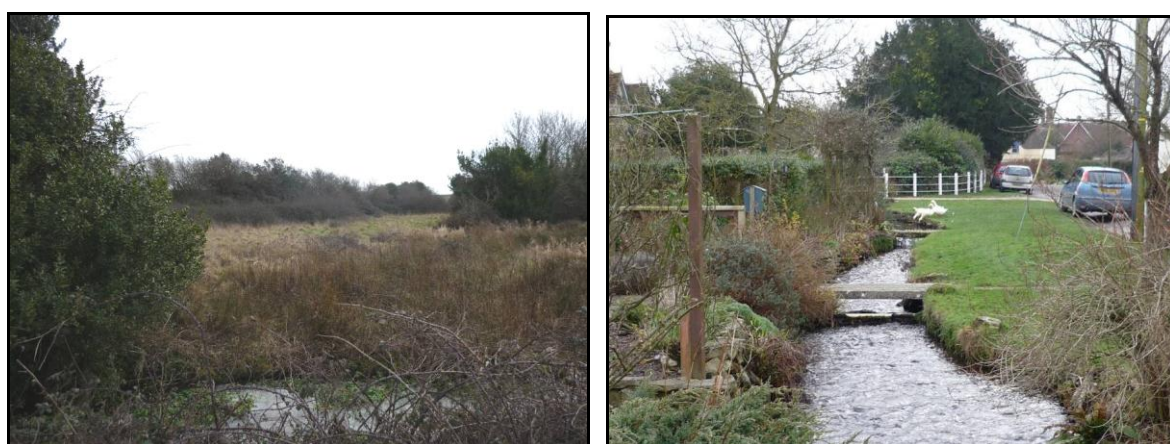
The small stream running through Spring Street is a delightful visual feature that also serves as a host for aquatic organisms and the insects, birds and mammals that feed upon them. The hedgerows, being of a native species, support wildlife throughout the year and help serve as wildlife corridors through the village.

FIG. 23: *The hedges, fields and trees to the east of the historical village provide a haven for wildlife. Ducks in Spring Street interact in the street scene.*

The old village is a relatively typical of a rural Dorset village, but its distinctiveness comes mainly from Spring Street (see FIG. 23), '*where typical thatched cottages stand back, so untypically [sic] for Dorset, behind broad grass verges*' (Newnan & Pevsner: 1972, 495). This is an important and unusual feature that contributes to the unique setting and rural character of the conservation area and is most probably owing to the watercourse that runs between the winding street and these properties. A consequence of this stream is that flora and fauna thrive and add to the street's tranquil feel.

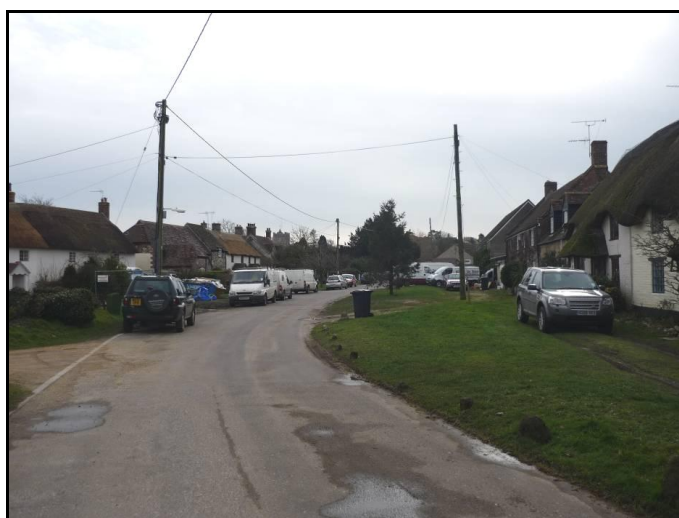
Perhaps the biggest problem experienced in Spring Street is the visual effect of vehicular traffic parking on grass verges. This is illustrated by FIG. 24, taken looking south down Spring Street, which shows how not only are vehicles parked in the street and creating a cluttered feel, some are being stationed on the grass verges and are eroding the distinction between public and private spaces. The stationing of domestic bins is another unfortunate modern addition that adds to clutter and further contributes towards a deterioration of the public realm. This illustrates the difficult balance that must be sought between the needs of modern society and the needs of conserving the historic environment.

The parking of large, commercial type vehicles on the grass near to the bakery is a related problem and is difficult to resolve – the bakery creates employment within the village and the mix of commercial and residential adds to the vibrancy. To place bollards on the grass would prevent parking, however it is likely that the number of vehicles then parked on the street would cause congestion and detract from the general street scene.

FIG. 24: *The stationing of vehicles, particularly in Spring Street is detracting from the quality of the street scene.*

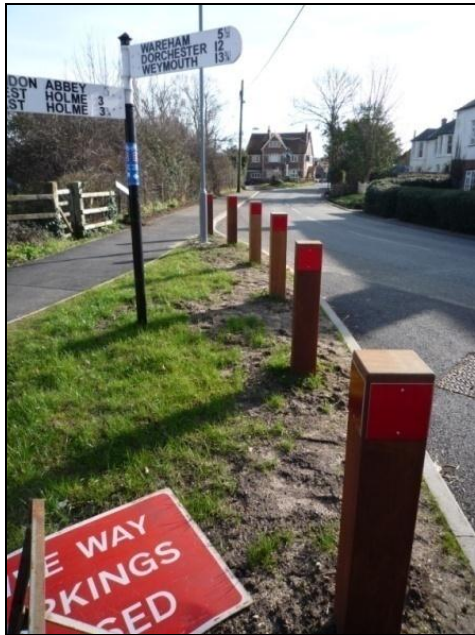
Council. Whilst not objectionable in principle, they have resulted in the insertion of high concrete kerbing stones and timber bollards – all alien to the materials and form of the conservation area.

FIG. 25: *Unsympathetic traffic calming measures at the north of the conservation area.*

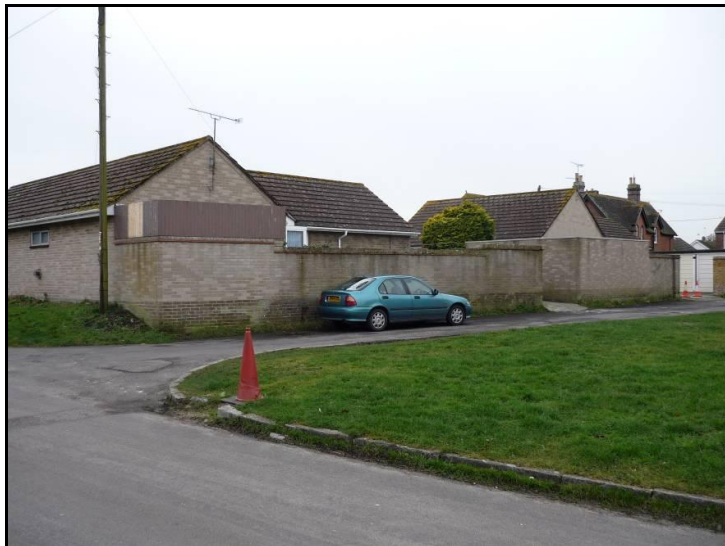
Located at the very centre of the conservation area, the cul-de-sac of bungalows at The Cross have blank, grey frontages facing the street and detract significantly from their surroundings, bearing no resemblance to the historic form of the village in either form or materials. This is a site with potential for enhancement works.

FIG. 26: *The Cross. Unsympathetic development in the conservation area.*

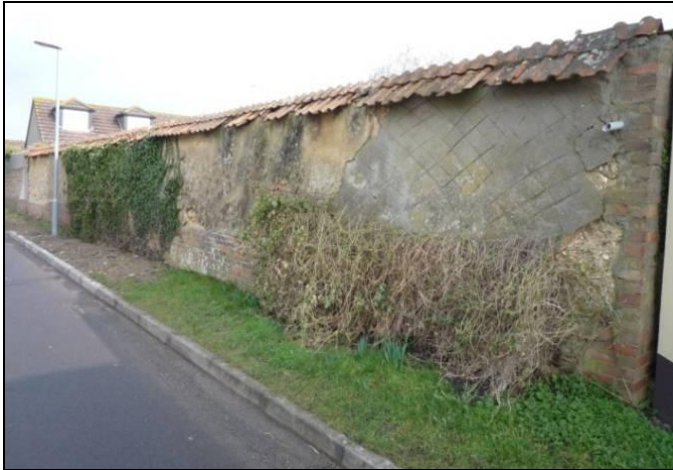
not listed in their own right, form important and interesting boundary features. These appear to be poorly maintained: the tile roofing slates are frequently missing, as are sections of render (possibly concrete instead of lime). The loss of the cob walls will be even more noticeable as the boundary treatment will most certainly need to be replaced – possibly by close boarded timber, which would not only be an alien boundary treatment historically but detract significantly from the current, more robust boundary treatment.

FIG. 27: Cob wall on the High Street in poor condition. Cement render used to repair the surface is causing further harm.

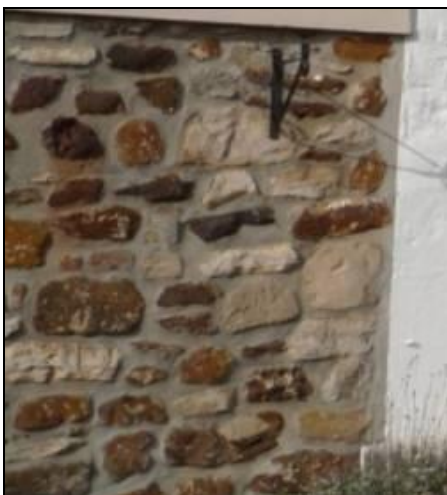
FIG. 28: Heavy handed pointing on this heathstone house has caused the pointing to be visually dominant.

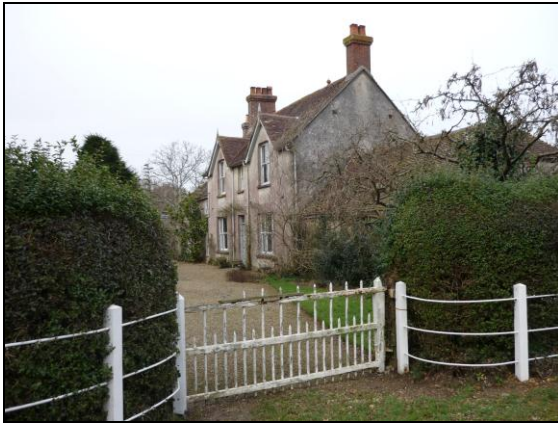
From external inspection it does not appear that there are any principal listed buildings within the conservation area that could be considered obviously 'at risk' through factors of neglect or maltreatment. However, Manor Farm on Church Lane does appear that it would benefit from renovation works.

FIG. 29: *Manor Farm on Church Lane could benefit from external improvements.*

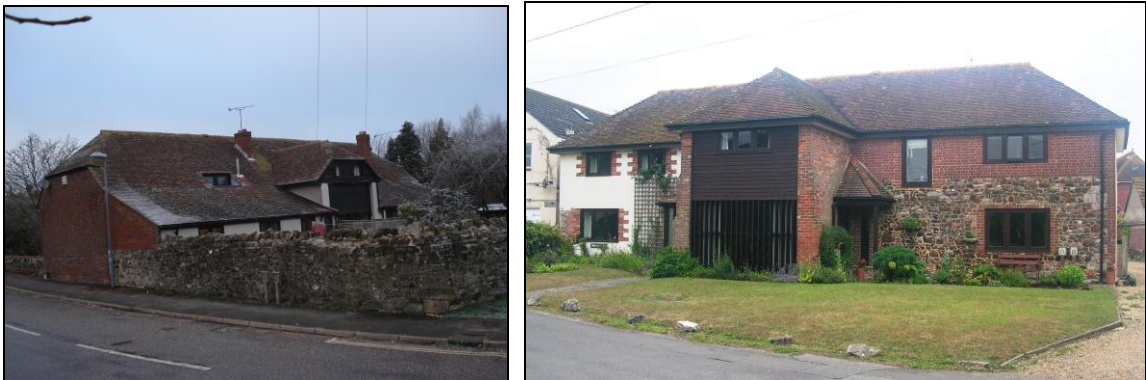
Obvious negative features, such as parking in Spring Street, small scale urbanisation and inappropriate highways improvements have already been identified above. Others include the inappropriate conversion of existing buildings. FIG. 30 below shows two listed barns which have been somewhat unsympathetically converted into dwellings.

FIG. 30: *Unsympathetic barn conversions at Colliers Barn, High Street and Poorhouse Barn, Spring Street.*
