## **Bat Emergence Survey Report**

Tess Square and Butts Close Hybrid  
Scheme, Marnhull

05/10/2023

Chapman Lily Planning  
Unit 5 Designer House  
Sandford Lane  
Wareham  
BH20 4DY

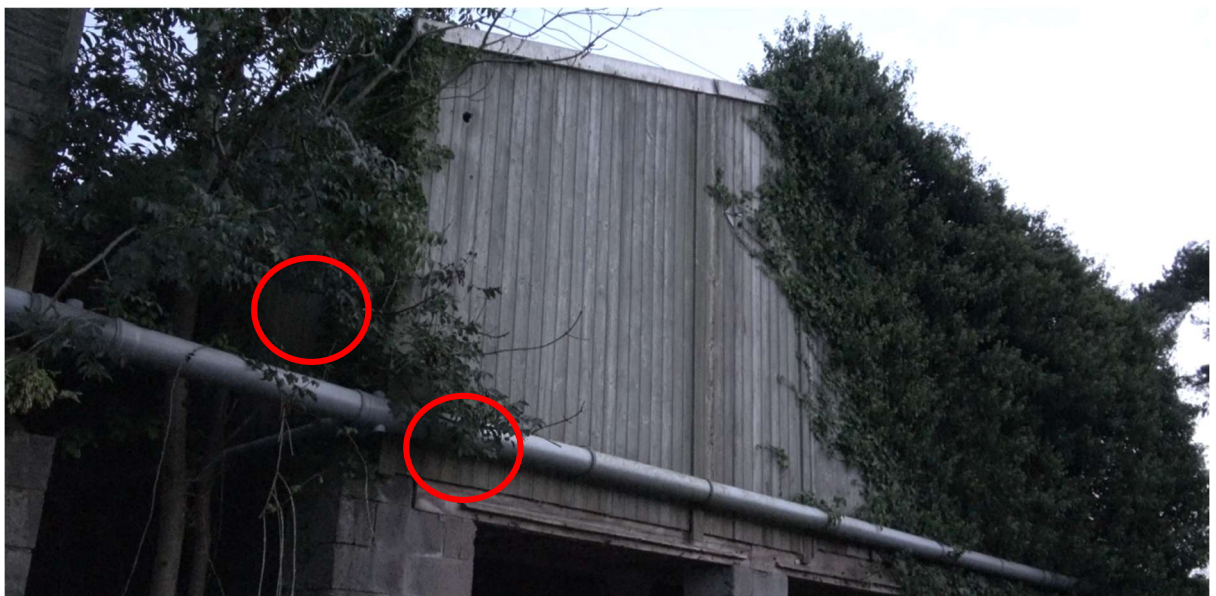
**Figure 1: One emergence was seen from the shrubbery on the north of the eastern side of the building (left circle) during the third survey. One emergence was seen from beneath the drainpipe on the northern side of the building (right circle) during the second survey. One re-entry was seen from the doors on the northern side of the building during the first survey. Two emergences and three re-entries were also seen from the shrubbery at the**

right of the photograph, but this was on the western side of the building (unphotographed). This was during the first survey.

- 4.3 It is considered that building 2 (barn) supports a day roost used by low numbers of common pipistrelles and soprano pipistrelles. Two emergences and four re-entries (all common pipistrelles) were recorded on the first survey. One emergence and one re-entry (of two common pipistrelles) was recorded on the second survey. Two emergences (of one common pipistrelle and one soprano pipistrelle) and one re-entry (of one common pipistrelle) were recorded on the third survey. The emergences and re-entries were recorded from five locations in total. The emergence locations are shown in the photographs below.

- 4.4 Low numbers of both common and soprano pipistrelles were recorded emerging from building 2. Based on the locations of the recorded emergences and the roosting preferences of pipistrelle species, it is considered that the bats were most likely utilising crevices in the interior and exterior of the building for roosting.
- 4.5 This roost is considered to be of 'low conservation importance'.
- 4.6 It is understood that building 2 is to be demolished. Due to the presence of a bat roost, a mitigation licence for bats will be required for these works. Further details are provided below.

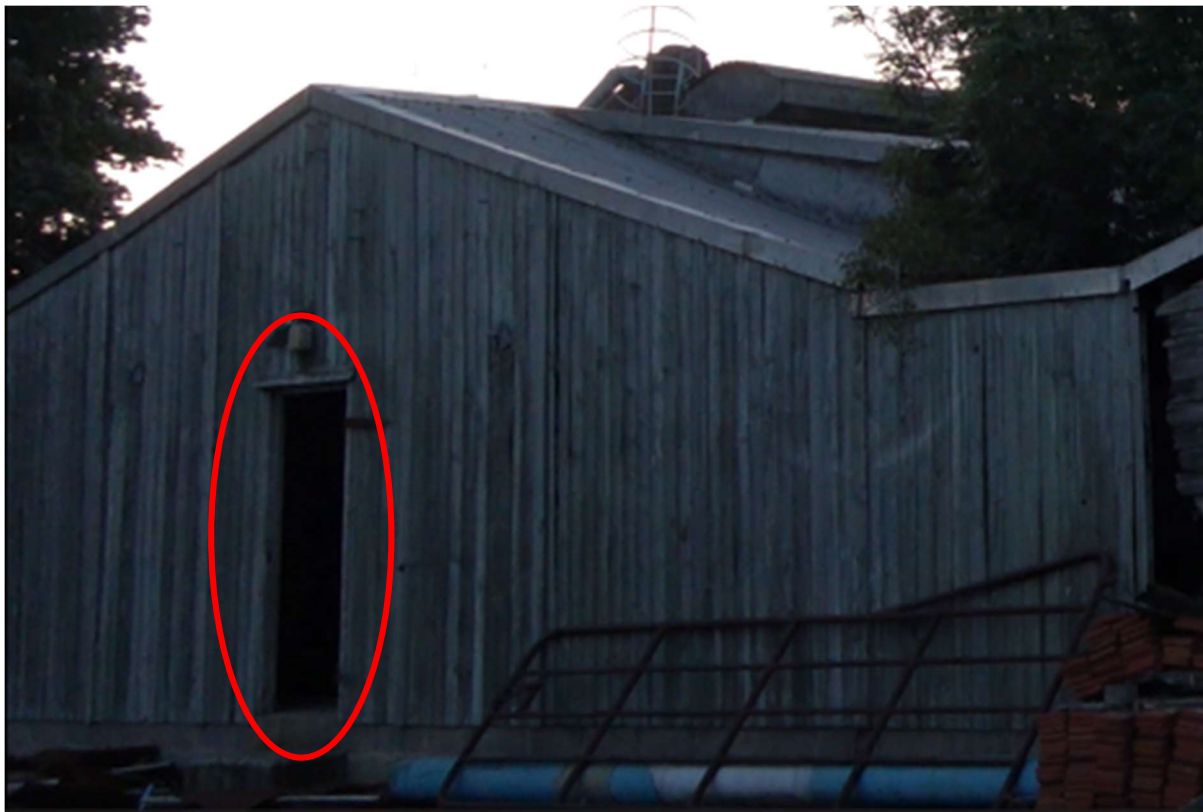
**Figure 2: On the southern side of the building, one emergence and two re-entries were seen from the door during the second and third surveys.**

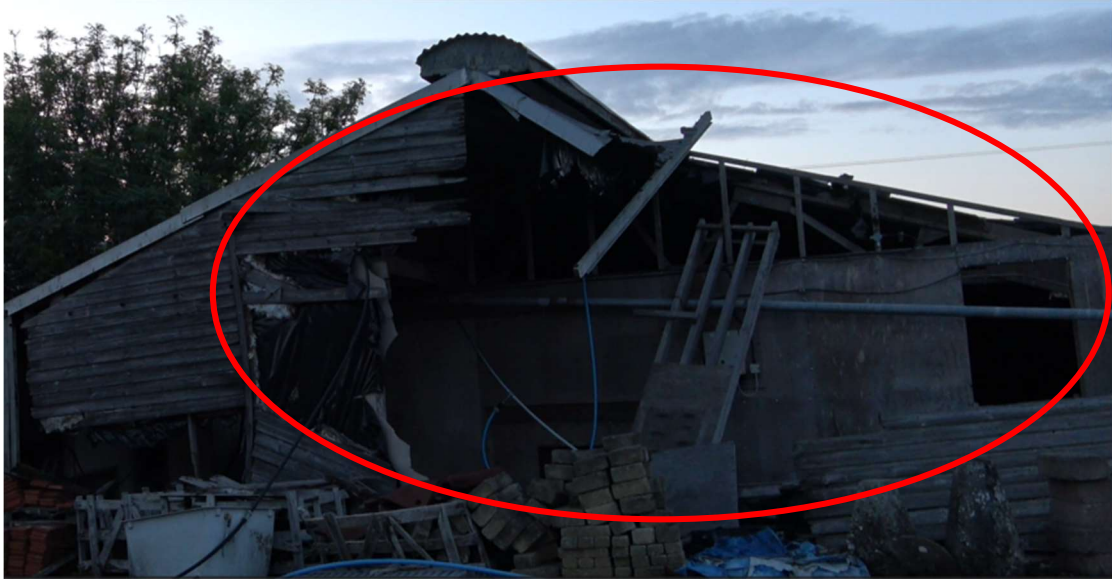
**Figure 3: At the southern side of the building, four emergences and one re-entry were seen from the damaged, open part of the structure. These were during the second and third surveys. At the northern side of the building (unphotographed), two emergences and three re-entries were seen from the doors during the first survey. Two emergences were also seen from the pipe at the north of the western side of the building (unphotographed) during the first survey.**

- 4.7 It is considered that building 3 (barn) supports a day roost used by low numbers of pipistrelles and brown long-eared bats. Four emergences (all common pipistrelles) and three re-entries (of common pipistrelles and one brown long-eared bat) were recorded on the first survey. Three emergences (of two common pipistrelles) were recorded on the second survey. One emergence and one re-entry (of one common pipistrelle) was recorded on the third survey. The emergences and re-entries were recorded from three locations in total. The emergence locations are shown in the photographs below.

- 4.8 Both common and soprano pipistrelles were recorded emerging from building 3. Based on the locations of the recorded emergences and the roosting preferences of pipistrelle species, it is considered that the bats were most likely utilising crevices in the interior of the building, as well as crevices and shrubbery on the exterior of the building for roosting. A brown long-eared bat was also recorded re-entering building 3. Based on the location of the recorded re-entry, it is considered that the bat was most likely utilising crevices in the interior of the building for roosting.
- 4.9 This roost is considered to be of 'low conservation importance'.
- 4.10 It is understood that building 3 is to be demolished. Due to the presence of a bat roost, a mitigation licence for bats will be required for these works. Further details are provided below.
