**RE: Site 1 Central Site – Hybrid Application, Marnhull - Infiltration Testing**

Omnia were commissioned by Chapman Lily Planning Limited, to undertake infiltration testing in general accordance with *BRE Digest 365 – Soakaway Design* at the above referenced site. Three (3no.) infiltration tests within locations SA101-SA103 were unable to be completed on 31<sup>st</sup> October to 1<sup>st</sup> of November 2022. Please find set out below a summary of on-site observations from site works undertaken on Tuesday 17<sup>th</sup> January, including presentation of infiltration rates within SA101-SA103.

Geotechnical	<b>Infiltration Testing Letter Report</b>					
	<b>Prepared by:</b>	A. Dodds	<b>Date:</b>	23.01.23	<b>Signature:</b>

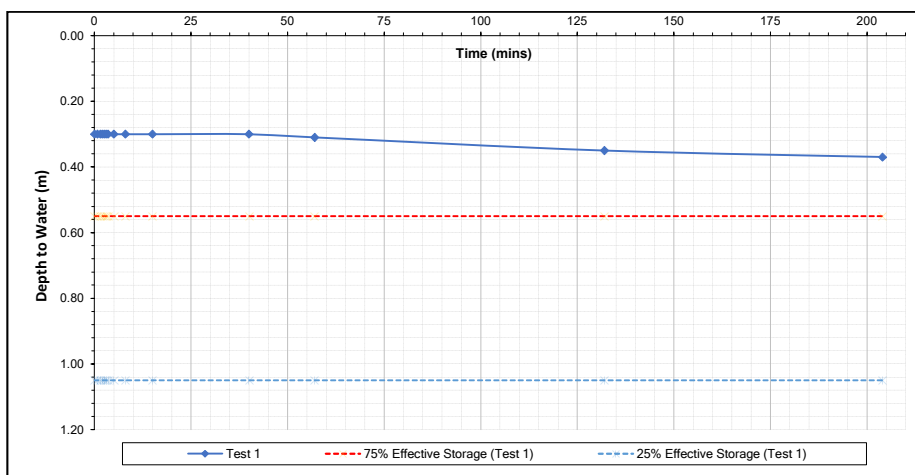
<b>Comments:</b>
<b>NOTE:</b> During the duration of the test the required intercept failed to be reached. Therefore the test is considered not to have been successful.

Both the 75% and 25% effective storage depths were not reached within Test 1 for SA101 and Test 1 for SA102. Therefore, the tests are not considered to have been successful.
