# Cob Walls in East Dorset

## Care & Repair

East Dorset District Council Planning Guidance  
Policy Planning June 2008

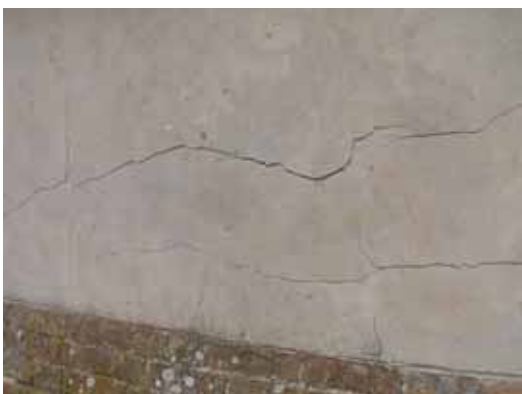
*Initial signs indicating that things are not what they should be.*

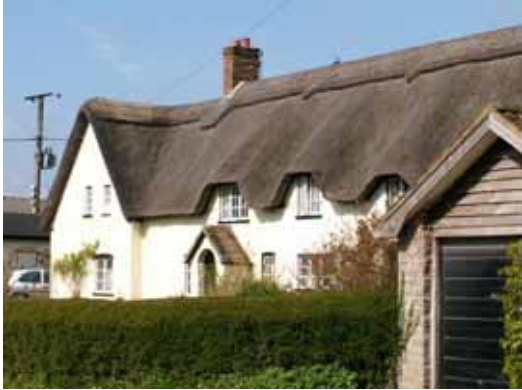
*17<sup>th</sup> C, chalk cob cottages in Pentridge.*

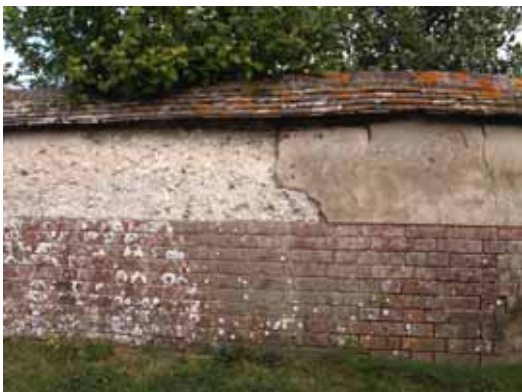
*Chalk cob over a high brick plinth. Note failing cement render.*

- Cement renders and modern impervious paints are two of the main causes for wall collapses. Cement render is too dense and heavy for the softer earth wall and frequently become detached from it. Hair-line cracks caused by normal daily thermal expansion and contraction of the hard material allow rainwater to penetrate between the render and cob. Water sinks to the bottom within the cavity and into the wall at the bottom, changing the consistency of the cob. Wall slumps are without warning and are dramatic, especially if you happen to be in the building at the time.

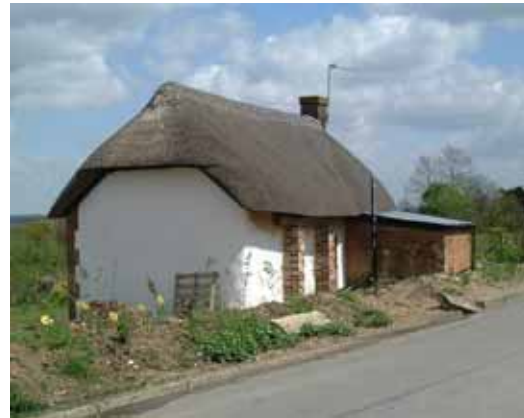
*19<sup>th</sup> c plastered cob cottage.*

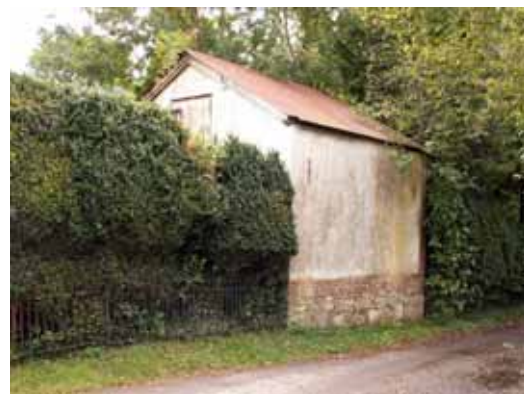
*Cob implement shed on a plinth of brick over green sandstone and flint. Such buildings are becoming increasingly rare.*

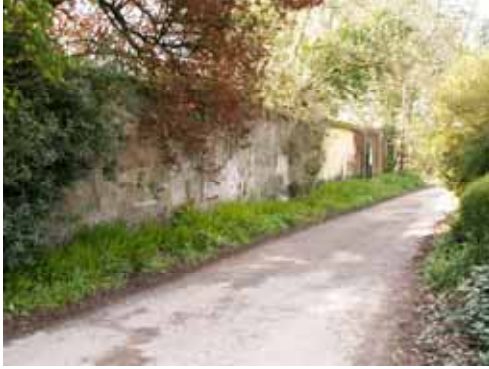
*Erosion of cob made worse by crude attempts to patch up. Free-standing cob walls are particularly susceptible to neglect.*

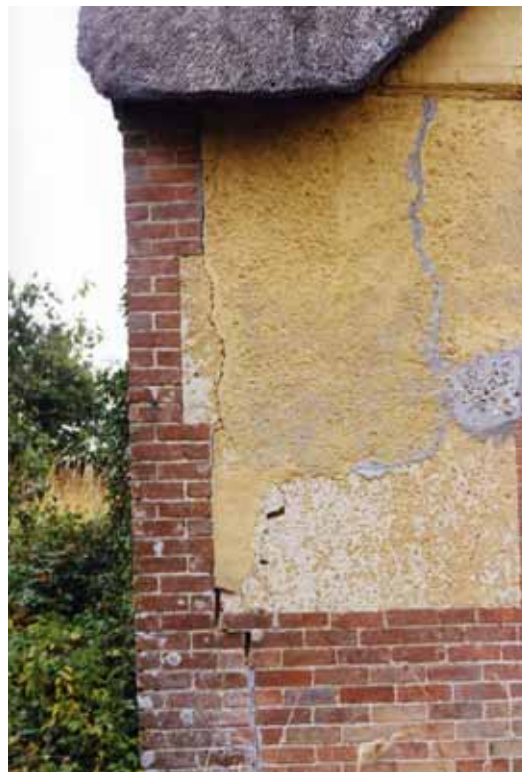
*Here the brick and cob have parted company and the wall is bowing out.*
